COLORADO CULTURAL RESOURCE SURVEY

Architectural Inventory Form

- 1. Resource number: **5WL.5629** Parcel number: **080716307007**
- 2. Temporary resource number: **Not Applicable**
- 3. County: **Weld**
- 4. City: **Windsor**
- 5. Historic building name: **Yancey Building; Alex Lorenz Tailor Shop; Cozy Inn**
- 6. Current building name: **Windsor Old Town Rentals**
- 7. Building address: **508-510 Main Street**
- 8. Owner name: **Star Contracting, Inc.**
- Owner organization:
- Owner address: **c/o Windsor Old Town Rentals**
- 505 Chestnut St**
- Windsor, CO 80550**

Downtown Windsor Survey

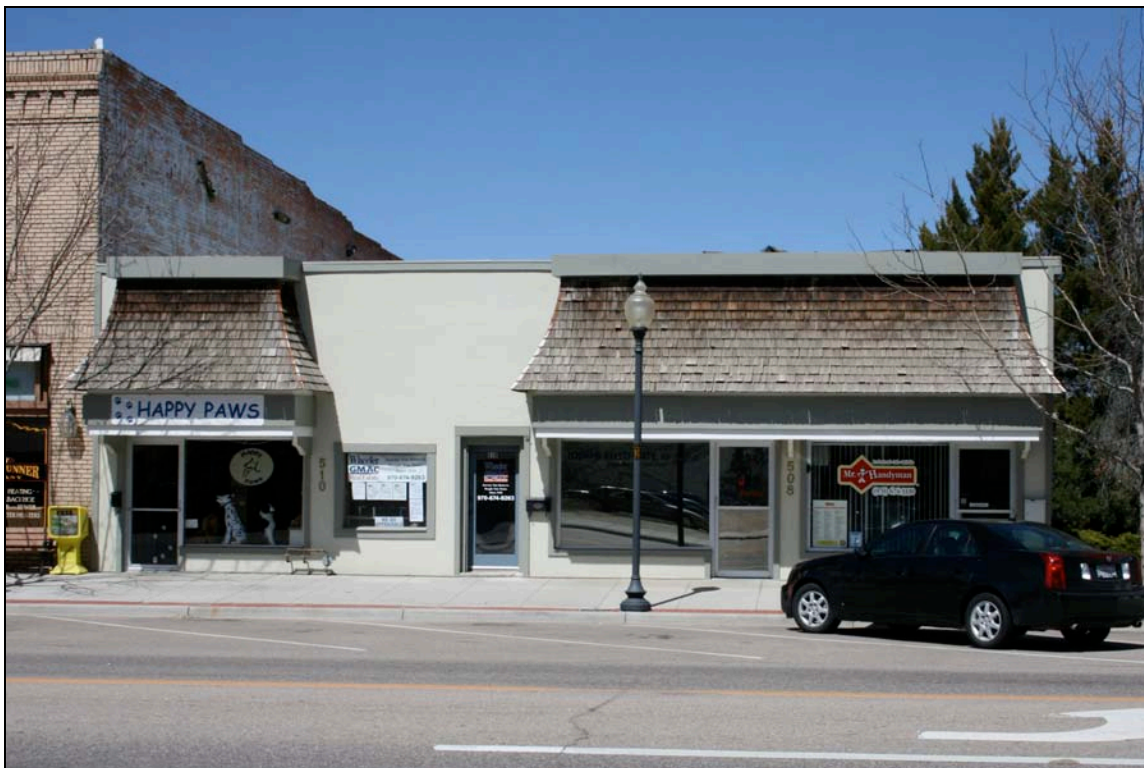
20. Special features: **Window/Glass Block**
Window/Segmental Arch
21. General architectural description:
Oriented to the south, this building appears to rest on a concrete foundation. The walls consist of red, pressed bricks set in a 6-over-1 common bond. Covering the façade is light green stucco. This building consists of four storefronts evenly spaced across the front façade. They are addressed from east to west as 508, 508 1/2, 510, and 510 1/2 Main Street. All but the 510 Main Street unit are identical. They consist of large, plate-glass windows, with aluminum frames, and plate-glass doors to the east, also with aluminum frames. Spanning above these three storefronts are mansard awnings, covered in unpainted, square-cut wood shingles, resting on scroll brackets. The remaining storefront (510 Main Street) hosts a smaller plate-glass window, with sea-foam green wood surrounds, to the west and a doorway to the east. The doorway hosts a glass-in-wood-frame door, with a blue-painted wood frame. This particular storefront lacks any awning. A sign reading "CAFE" is painted vertically on the bricks at the southernmost end of the east elevation. The depth of the four units as seen from the rear (north) elevation varies greatly. 508 and 510 Main Street are the deepest portions of the building. 510 1/2 Main Street is the shallowest, with 508 1/2 Main Street in between these extremes. Opening just west of center in the rear elevation of 508 Main Street is a gray-painted metal slab door. A glass-block window pierces the west end of the same elevation of this particular unit. Spanning above this elevation are three pieces of tan-painted, horizontal wooden composition siding. The rear elevation of 508 1/2 Main Street also contains a slab door, to the east, and a window opening, to the west. The window opening has been boarded shut. A doorway opens in the eastern half of rear elevation of 510 Main Street. It hosts a gray-painted metal slab door. A window opening west of this doorway has been boarded shut. Opening east of center in the rear elevation of 510 1/2 Main Street is a doorway with a segmental arch. It hosts a white-painted, wood slab door. The transom has been boarded shut, as well as a tall, narrow window opening west of the doorway. The window opening also has a segmental arch. A rubber membrane cover the nearly flat roof, which parapets segment into the corresponding four units.
