COLORADO CULTURAL RESOURCE SURVEY

**Architectural Inventory Form**

- 1. Resource number: **5WL.5631** Parcel number: **080716307006**
- 2. Temporary resource number: **Not Applicable**
- 3. County: **Weld**
- 4. City: **Windsor**
- 5. Historic building name: **Yancey Livery Stable; Windsor Motor Car Company; Streeb's Garage**
- 6. Current building name: **Brunner Building; John Brunner & Company**
- 7. Building address: **512 Main Street**
- 8. Owner name: **John G. Brunner, Mary Brunner, and Sherron A. Brunner**
- Owner organization:
- Owner address: **33847 Siasconset Rd  
Windsor, CO 80550**

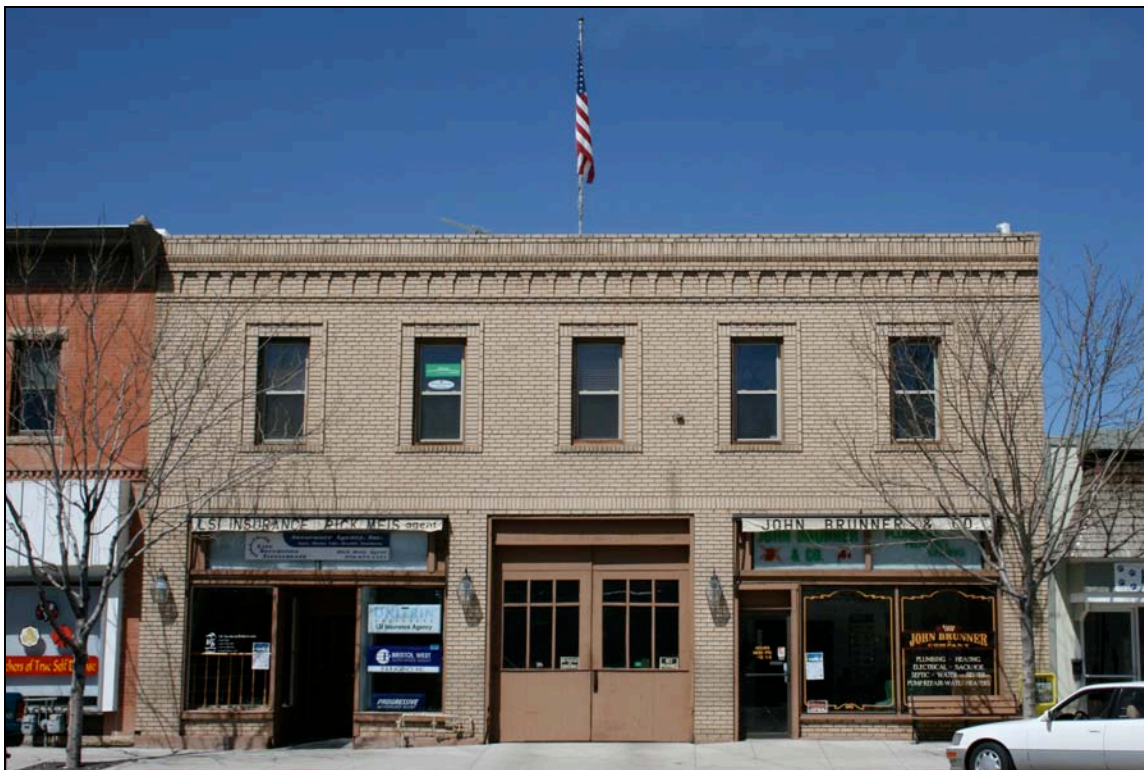
20. Special features: **Roof Treatment/Decorative Cornice**  
**Window/Glass Block**
21. General architectural description:  
**This building is oriented to the south. The nature of the foundation could not be determined. The walls of the original portion of the building consist of red, pressed bricks, set in a 7-over-1 common bond. The bricks are painted white on the exposed east elevation. Cladding the front (south) façade is a veneer of tan, glazed bricks. The brickwork features a belt course above the first story and a protruding, elaborately corbelled cornice. A large, single-story addition across the rear (north) elevation has sheet metal walls. The first story of the symmetrical façade features two larger storefronts flanking a slightly smaller garage opening at the center. The storefronts have plate-glass windows and doors, with brown wood frames. The doorway for the east storefront opens to the west while the doorway for the west storefront opens in the center. Spanning above the doorways and windows are transoms, shaded beneath retractable canvas awnings. Dominating the center of the façade's first story are paired, 6-light wood doors, painted brown. Evenly spaced across the façade's second story are window openings hosting 1-over-1-light, double-hung sash windows, with brown-painted wood frames. Framing each window opening is elaborate brickwork. Punctuating the first story of the east elevation are six small window openings. Each has been boarded shut. The first story of the rear elevation could not be surveyed due to high walls surrounding the northern half of the property. However, the second story hosts two window openings. The eastern opening now has glass blocks while the western opening has been boarded shut. A rubber membrane covers the nearly flat main roof, while sheets of metal cover the shed roof of the addition. A flagpole protrudes above the center of the front (south-facing) parapet.**

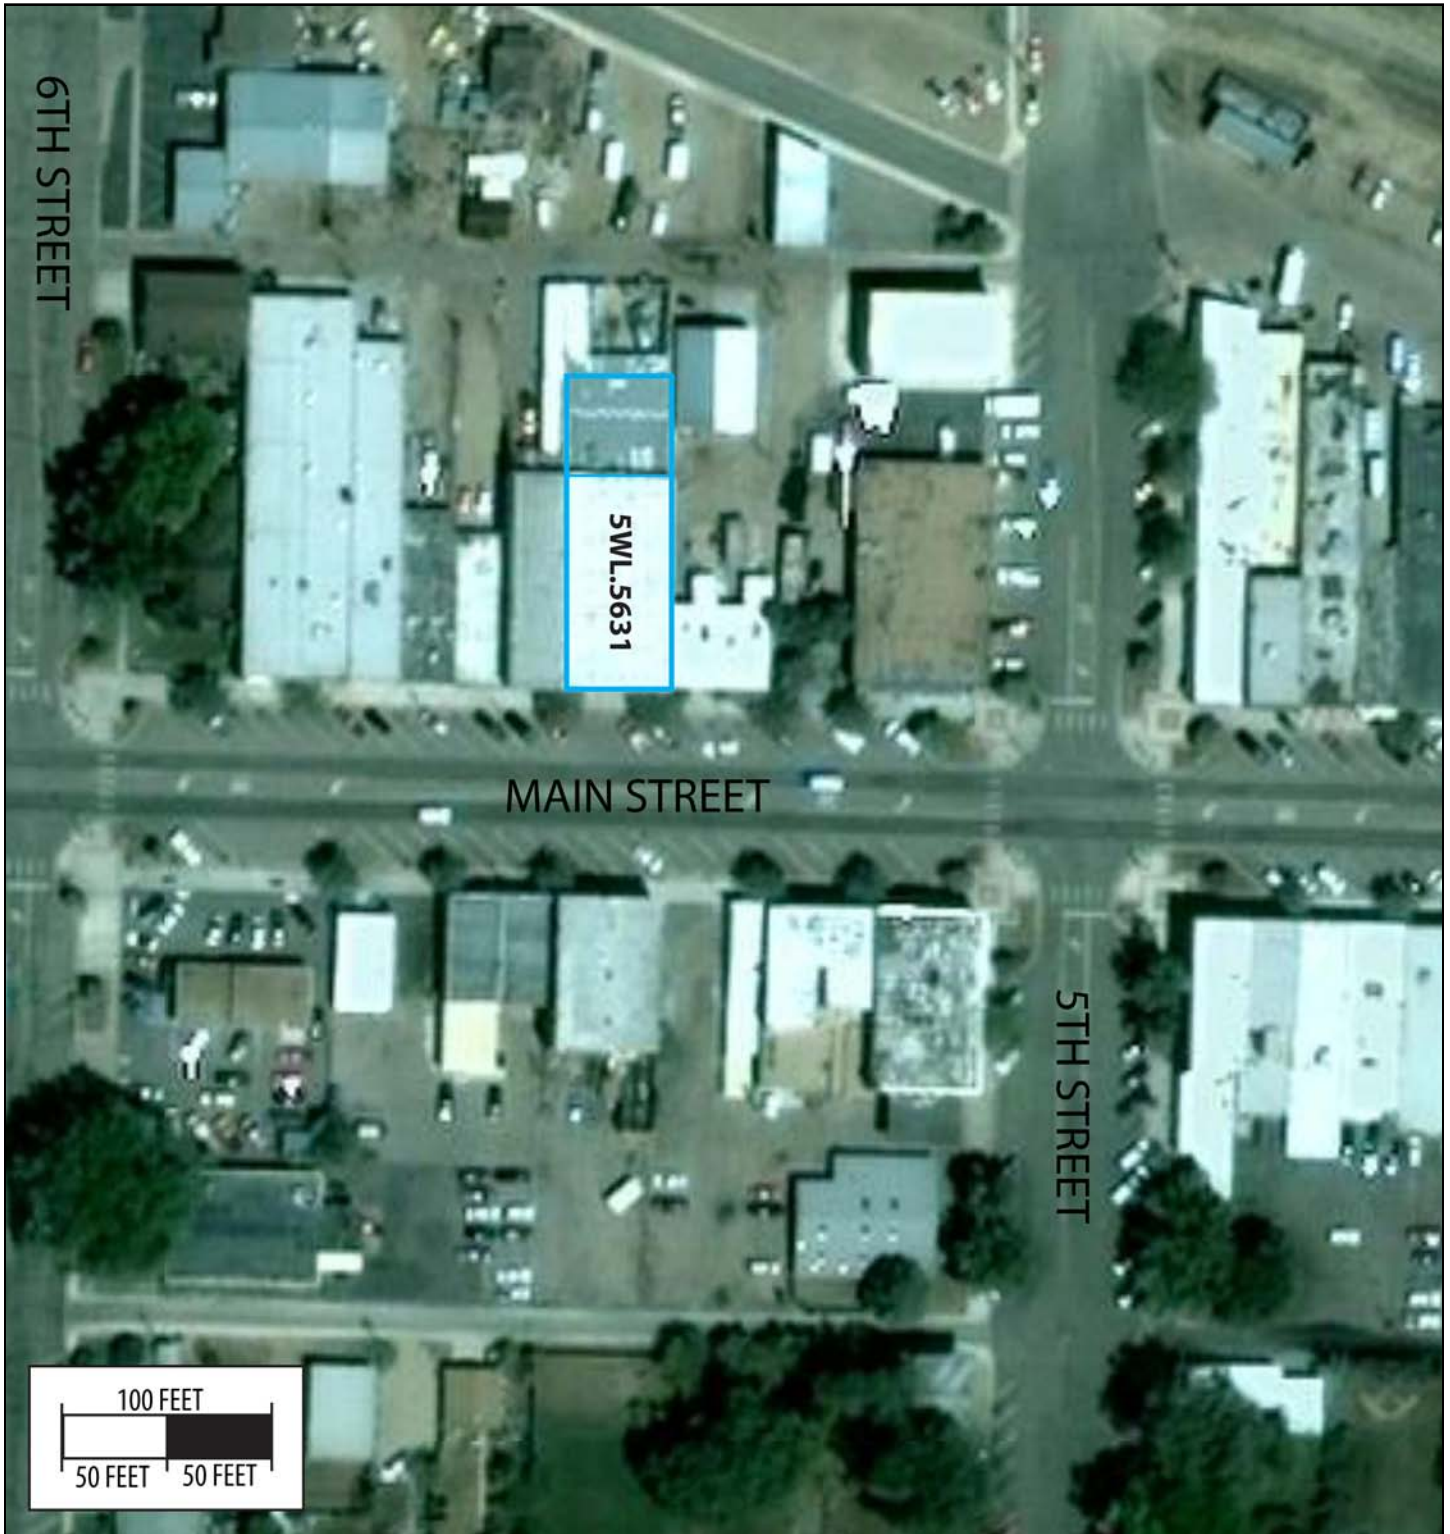
**SKETCH MAP**

**This commercial building is located on Main Street, the principal east-west thoroughfare through downtown Windsor. It is situated on the north side of the street, between 508-510 Main Street to the east and 514 Main Street to the west. Separating the building's front (south) facade from the street is a concrete sidewalk. Brick and concrete block walls surround the northern half of the property.**
