COLORADO CULTURAL RESOURCE SURVEY

**Architectural Inventory Form**

- 1. Resource number: **5WL.5636** Parcel number: **080716307004**
- 2. Temporary resource number: **Not Applicable**
- 3. County: **Weld**
- 4. City: **Windsor**
- 5. Historic building name: **520 Main Street**
- 6. Current building name: **Hergenreder Real Estate; Papa Hank's BBQ**
- 7. Building address: **520 Main Street**
- 8. Owner name: **Edward D. Hergenreder**
- Owner organization:
- Owner address: **1005 Cottonwood Dr  
Windsor, CO 80550**

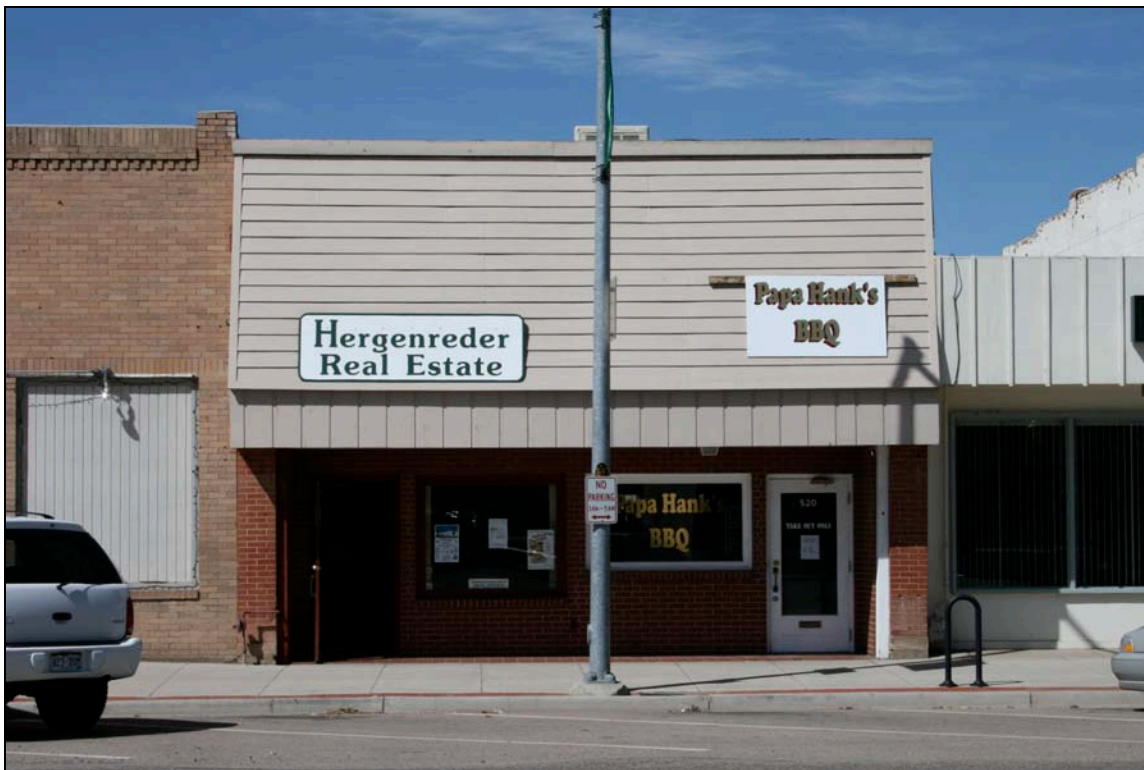
19. Primary external roof material: **Asphalt Roof**  
Other roof materials:
20. Special features: **Chimney**
21. General architectural description:  
**Oriented to the south, this building rests on a sandstone foundation. The walls consist of red, pressed bricks; northern portions of the building's east wall have a mixture of bricks and concrete blocks. A red, pressed-brick veneer covers the lower half of the front (south) façade. Cladding the upper half of the façade is tan, wooden composition siding. A box awning of tan-painted plywood separates the two façade treatments. White-painted sheets of plywood clad the rear (north) elevation. Doorways open in either end of a shallow recess extending across the façade. Each hosts a single-light, glass-in-wood-frame door. The eastern door is painted white; the western door is red. Between the doorways are two, plate-glass windows of different sizes. The eastern window has a white-painted frame while the western window has a red-painted frame. They both have brick sills. A secondary doorway opens in the eastern half of the rear elevation. It hosts a gray-painted, 6-panel steel door. Opening east of center is a 1-beside-1-light, sliding-sash window, with an aluminum frame. Spanning the rear elevation is a pent roof, covered in sheets of gray asphalt. Similar material covers the nearly flat roof. A red-brick chimney protrudes near the northwest corner of the roof.**
