COLORADO CULTURAL RESOURCE SURVEY

Architectural Inventory Form

- 1. Resource number: **5WL.5638** Parcel number: **080716307003**
- 2. Temporary resource number: **Not Applicable**
- 3. County: **Weld**
- 4. City: **Windsor**
- 5. Historic building name: **Bartz Garage; Service Garage; Charles A. Flinn Agency; Star Lite Café**
- 6. Current building name: **Duke of Windsor Sports Bar & Grill; Moonlight Grille**
- 7. Building address: **522-526 Main Street**
- 8. Owner name: **Windsor Enterprises, Inc**
- Owner organization:
- Owner address: **526 Main St
Windsor, CO 80550**

Downtown Windsor Survey

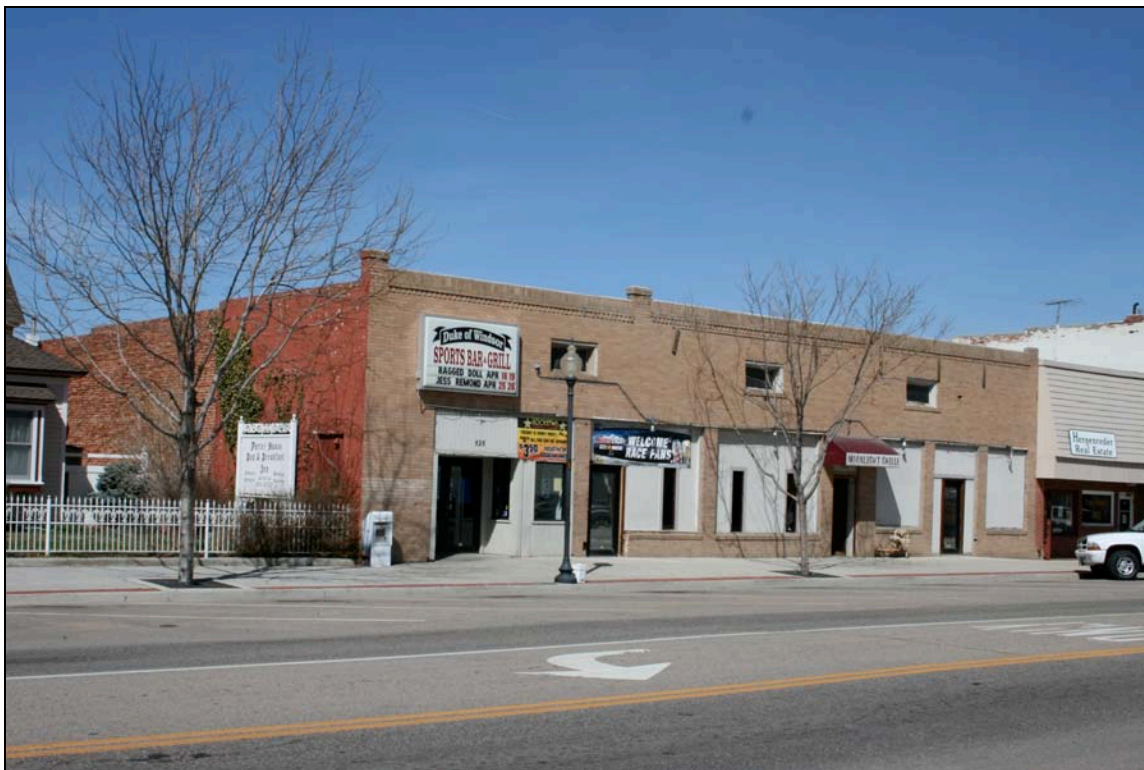
20. Special features: **Chimney**
Roof Treatment/Decorative Cornice
21. General architectural description:
Oriented to the south, this building appears to rest on a concrete foundation. The walls consist of red, pressed bricks, set in a 7-over-1 common bond. Cladding the front (south) façade is a tan, pressed-brick veneer. All window openings in the façade have brick sills. Unpainted stucco covers portions of the rear (north) elevation. Large window and door openings across the façade have all been enclosed with tan-painted sheets of plywood. Windows opening within the plywood are narrow, single-light fixed-frame. Plate-glass doors opening in the center of the eastern third, between the eastern and center thirds, near the center of the western third, and within a recess at the western end of the building. Three, small, single-light clerestory windows punctuate the façade. Above them is a shallowly protruding, corbelled cornice. Windows in the side elevations have concrete sills and have all been boarded shut. Three doorways open in the rear elevation. One opens in the center of the eastern third of the building. The other two open in either face of the northeast-facing corner of the central third of the building. The east-facing door hosts a gray-painted wood slab door. Just south of it is another doorway that has been boarded shut. The north-facing door hosts a white-painted, three-panel metal door. A large garage doorway in the north elevation has been enclosed with concrete blocks. Gray sheets of asphalt cover the nearly flat roof, and the parapets above the side elevation are stepped. A large, red-brick chimney protrudes from near the center of the eastern third of the building.
