COLORADO CULTURAL RESOURCE SURVEY

**Architectural Inventory Form**

- 1. Resource number: **5WL.5639** Parcel number: **080721204001**
- 2. Temporary resource number: **Not Applicable**
- 3. County: **Weld**
- 4. City: **Windsor**
- 5. Historic building name: **Kraft Frontier Station; Jim's Frontier Station; Jim's Husky Service; Windsor Husky Service**
- 6. Current building name: **Vogel Sales**
- 7. Building address: **529 Main Street**
- 8. Owner name: **James Henry Deiffenwierth II**
- Owner organization:
- Owner address: **421 Mayfair Ct  
Hurst, TX 76054-3534**

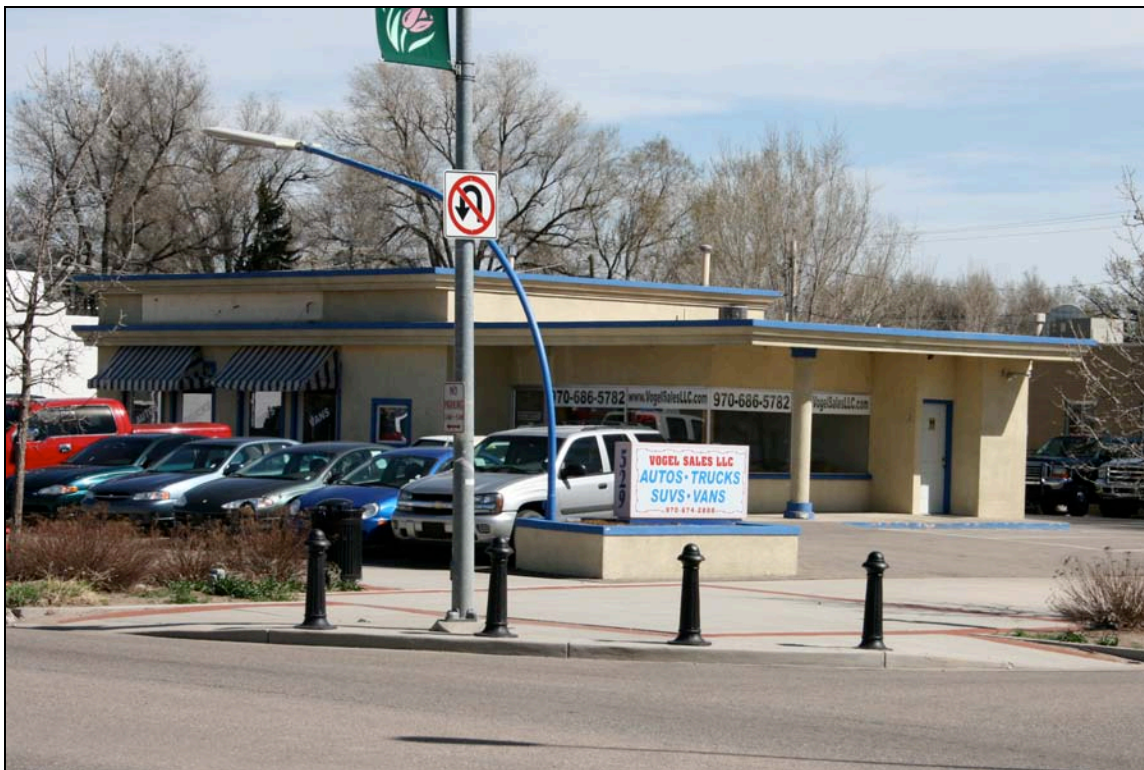
20. Special features: **None Applicable**
21. General architectural description:  
**Oriented to the north, this building rests on a concrete foundation. Yellow stucco with blue trim clads the exterior walls. Windows are generally plate glass, with wood and metal frames. Blue-and-white-striped canvas awnings shade the windows at the north end of the asymmetrical façade. Small windows open high in the western half of the rear (south) elevation. The principal doorway opens in the western half of the façade, beneath a flat-roofed porch, with a round column at its northwest corner. The doorway hosts a plate-glass door with a metal frame. Another doorway provides access to a restroom at the south end of the west elevation. It hosts a white-painted, six-panel steel door. Opening near the center of the eastern half of the rear elevation are single-light French doors. At the east end of the same elevation is a 2-light, steel, overhead-retractable garage door, painted yellow. A rubber membrane covers the flat roof, and the broadly overhanging eaves are boxed.**

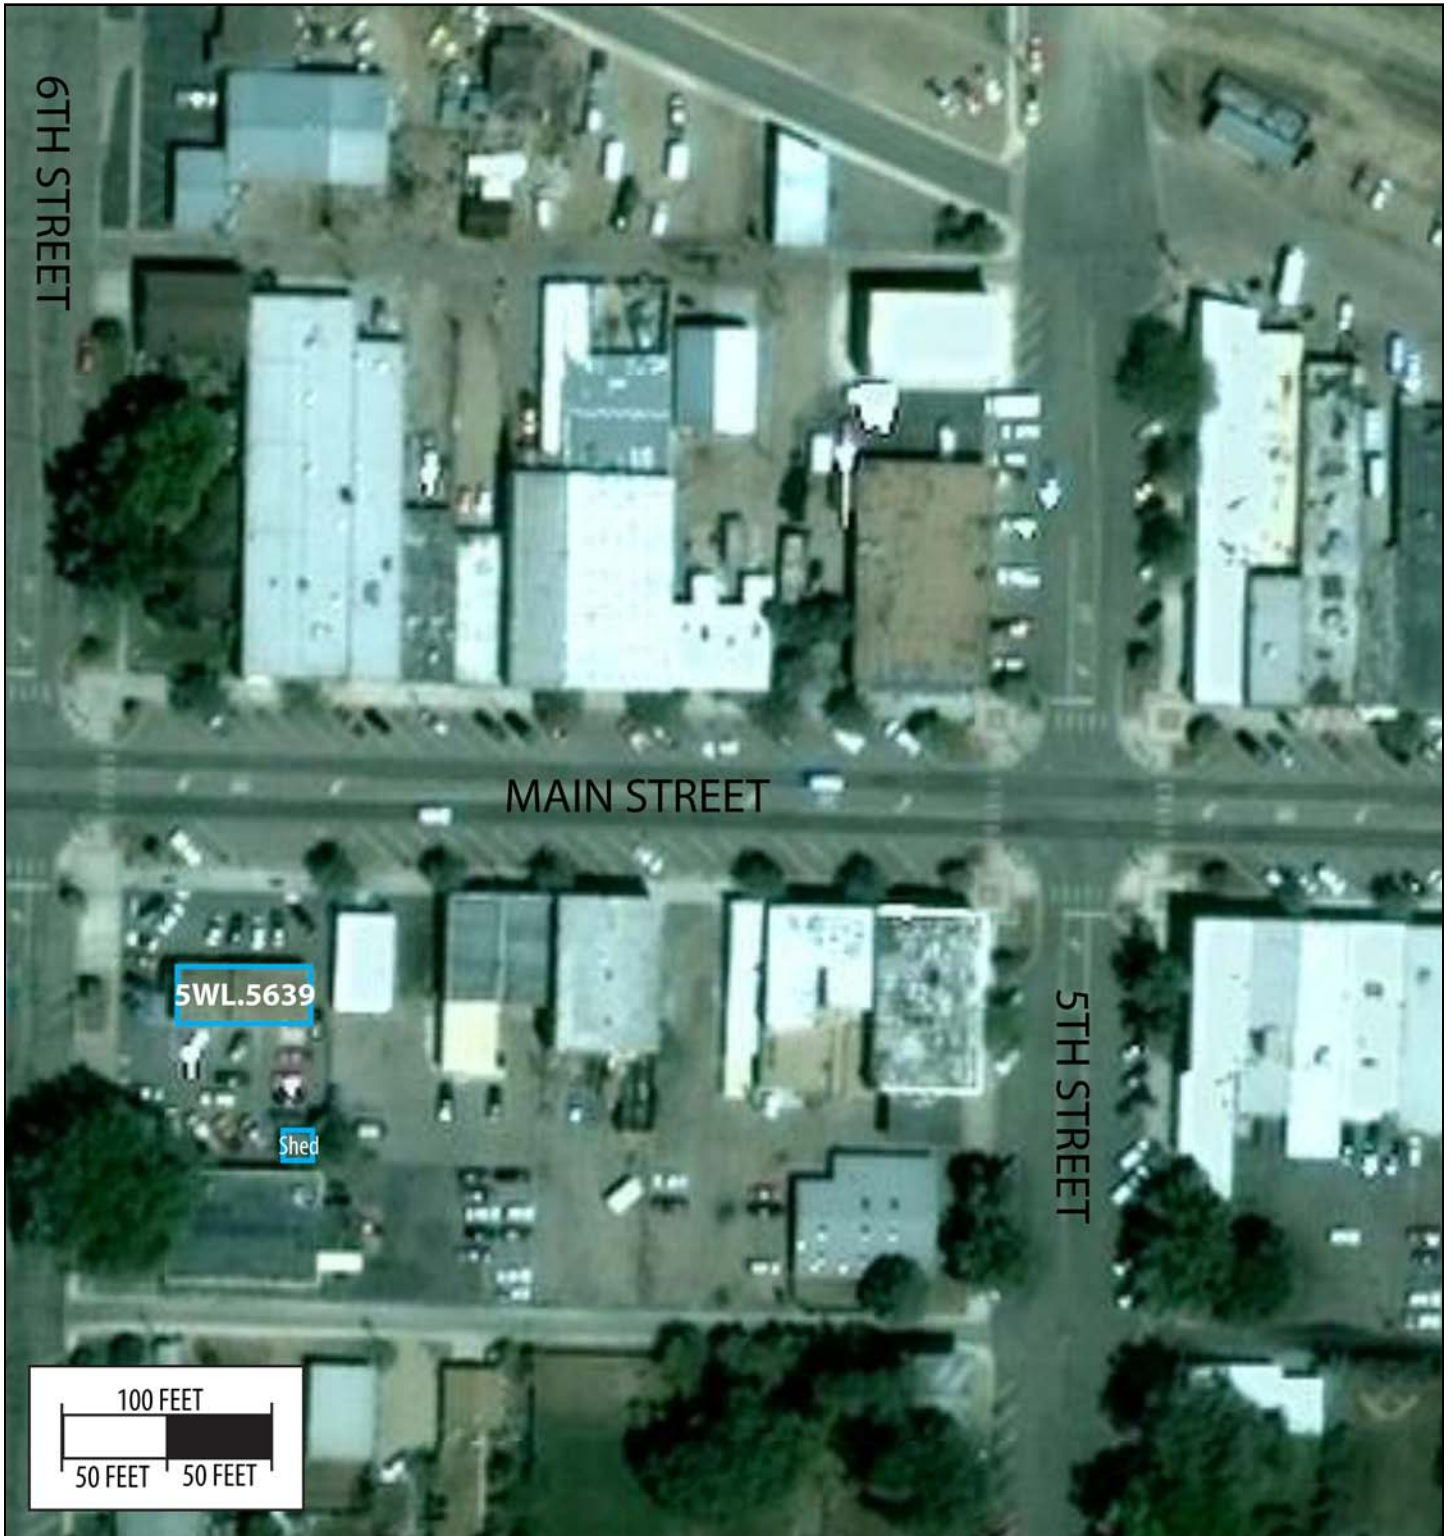
**SKETCH MAP**

**The property is located on the southwest corner of Main and 6th Streets in Windsor's downtown commercial district. Macadam covers most of the lot. However, mature landscaping is situated within planting beds at the corner of the property.**

24. Associated building, features or objects:  
**Storage Shed**  
**A storage shed is located on the southeast corner of the property. Oriented to the north, the building lacks a formal foundation. Covering the walls are yellow-painted sheets of corrugated metal. A doorway opens in the east end of the front elevation. It hosts a white-painted wood slab door. Sheets of corrugated metal cover the side-gabled roof.**
