## COLORADO CULTURAL RESOURCE SURVEY

**Architectural Inventory Form**

1. Resource number: **5LR.12778**
2. Temporary resource number: **City-13**
3. County: **Larimer**
4. City: **Fort Collins**
5. Historic building name: **Not applicable**
6. Current building name: **Professional Offices**
7. Building address: **417 West Mountain Avenue**
8. Owner name: **417 Mountain, LLC**
- Owner organization:  
**417 W. Mountain Avenue**
- Owner address:  
**Fort Collins, CO 80521**

Fort Collins Post-World War II Survey

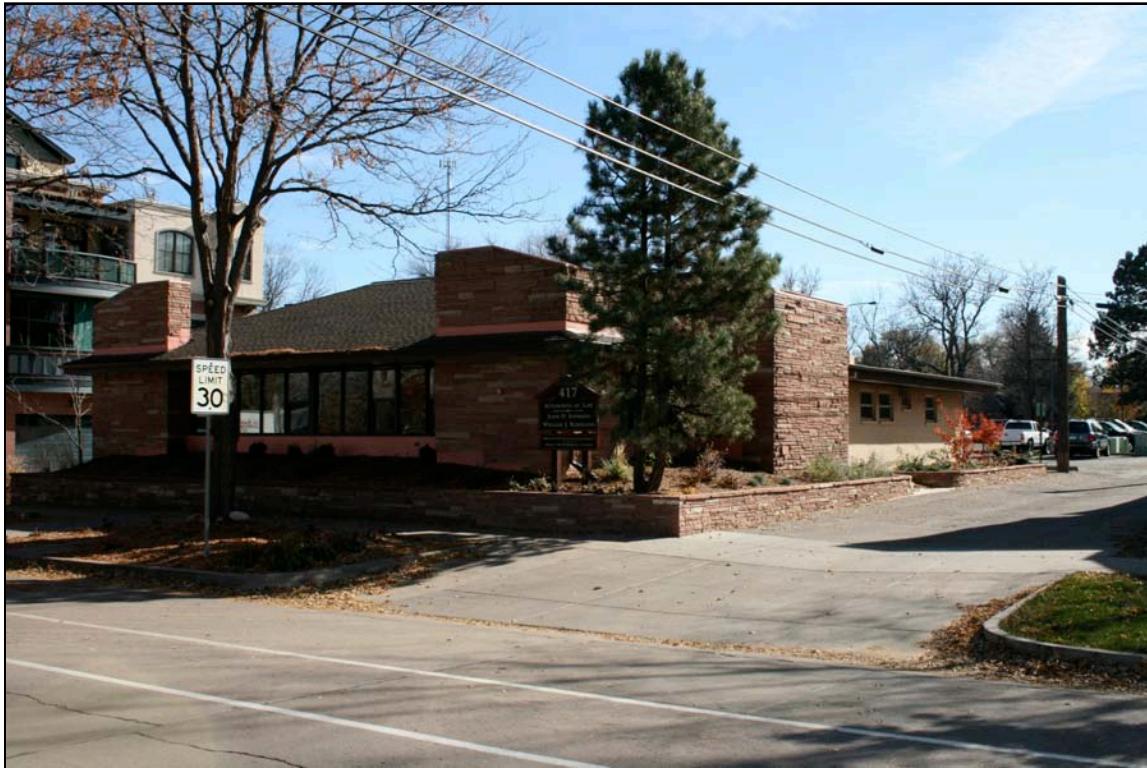
20. Special features: **None Applicable**
21. General architectural description:  
**Oriented to the north, this rectangular Modern Movements office building rests on a concrete foundation. It has a mixture of sandstone and blonde brick siding and a hipped roof with overhanging eaves and a wide, wooden cornice painted chocolate brown. Three sandstone "towers"—two located along the façade and a third along the west elevation—appear on this building. These structural elements have an appearance similar to the prominent stone chimneys featured on many domestic commissions of this same vintage. These towers all pierce the roof surface. Between the towers at the corners of the façade and tucked under the overhanging eaves, there are nine fixed pane tinted windows with fixed pane transoms. At least three of these windows appear to have operable screens and the overhanging eave is faced in thin strips of stained wood. There are two entries near the front of the building. The one facing south is a tinted glass door with the names of the building occupants on the surface of the door; it is located within the stone tower near the northwest corner. The second entry faces west and is also a tinted glass door flanked by fixed pane windows of similar tinted glass. A concrete stoop with at least one curved step allows access to these entries from the alley and nearby sidewalk.**

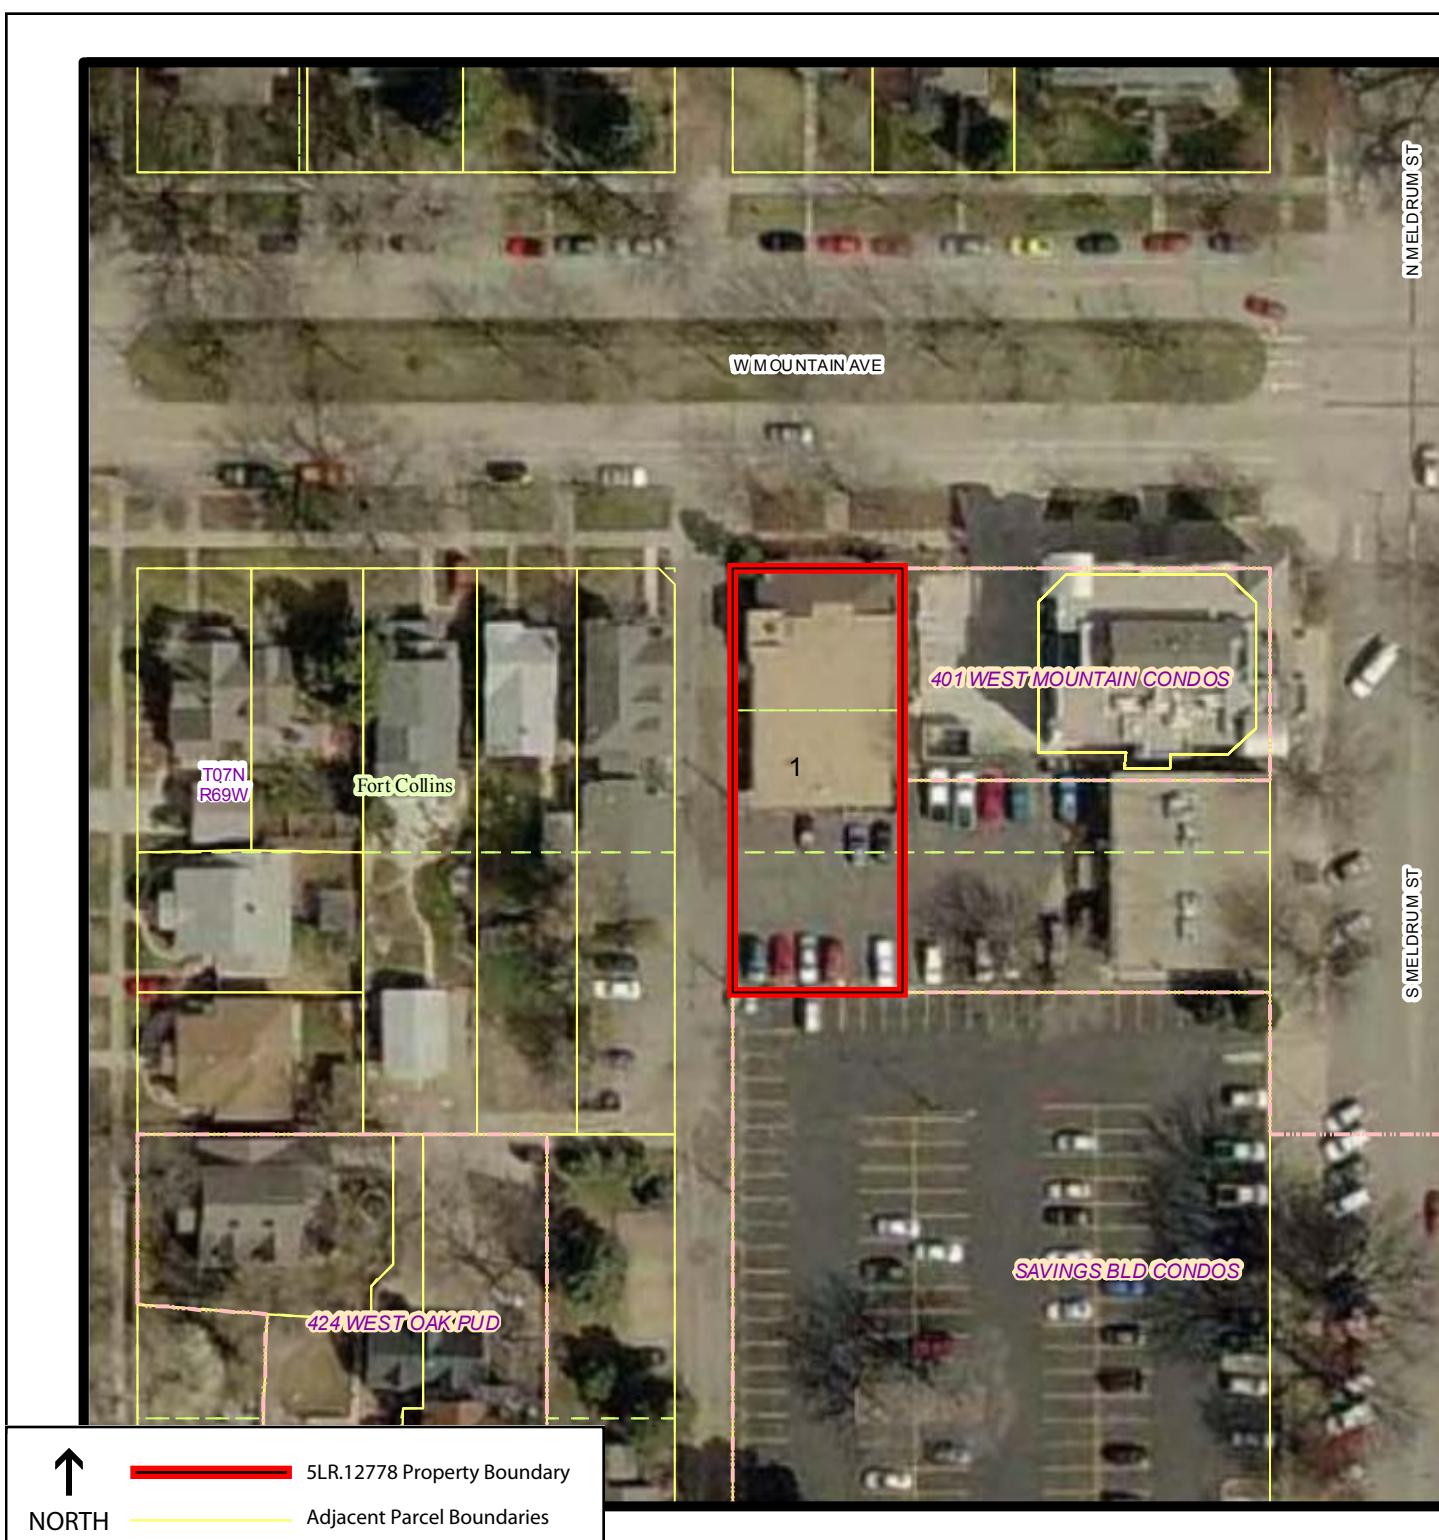
**SKETCH MAP**

This building is located near the front of a series of square lots. A half-height stone wall defines the front of the building perimeter along the sidewalk near W. Mountain Avenue. There is a prominent sign, constructed of stone and wood, near the northwest corner of the building. There is a parking lot behind the building and an alley along the west side. The planter along the west side of the building contains deciduous trees and bushes. The elevation of this lot is 5003 feet above mean sea level.
