COLORADO CULTURAL RESOURCE SURVEY

Architectural Inventory Form

1. Resource number: **5PE.517.67** Parcel number(s):
2. Temporary resource number: **525422002**
3. County: **Pueblo**
4. City: **Pueblo**
5. Historic building name: **1117 West Street**
6. Current building name: **Archuleta-Johns House**
7. Building address: **1117 West Street**
8. Owner name: **Toby Archuleta and Gloria Johns**
- Owner organization:
- Owner address: **1117 West St**  
**Pueblo, Colorado 81008**

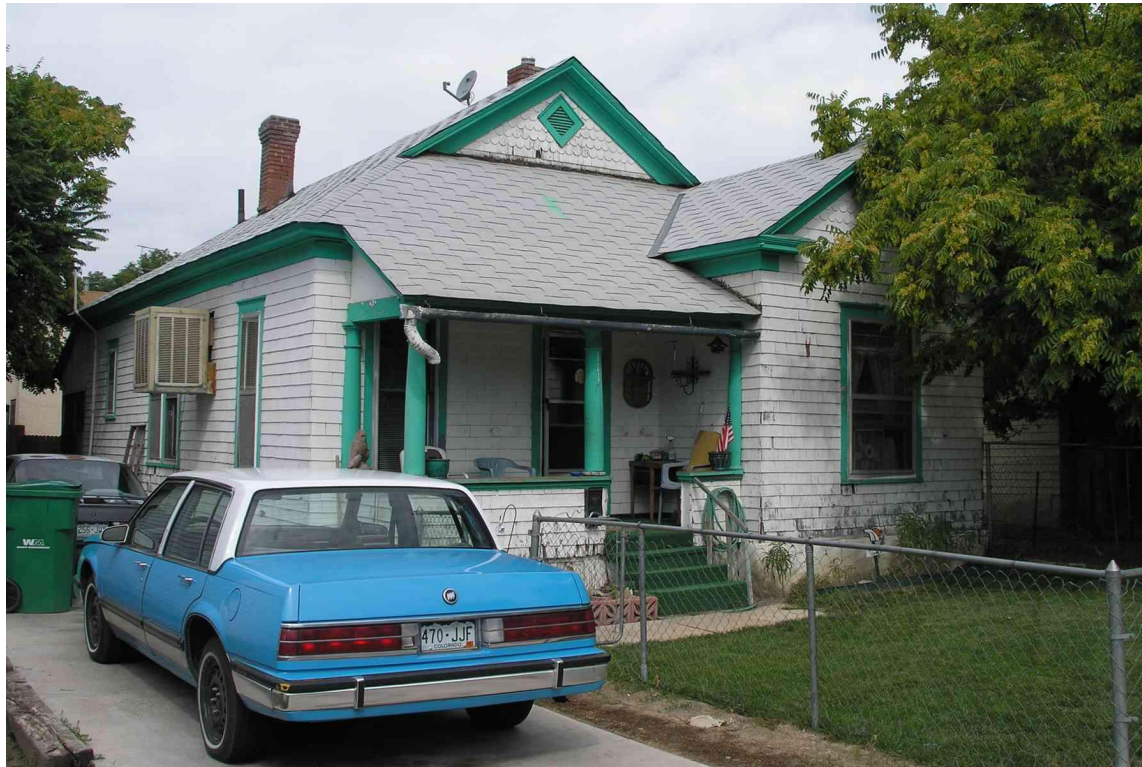
21. General architectural description:  
**Oriented to the east, this house rests on a white-painted concrete foundation. White-painted, square-cut wood shingles clad the exterior walls, and variegated wood shingles cover the gables. Covering the exterior walls of a shed-roofed addition across the rear (west) elevation is white-painted beadboard. Windows are generally 1-over-1-light, double-hung sash, with white-painted wood frames and green-painted wood surrounds. The rear addition has 6-light hopper or awning windows. A shed-roofed porch spans the inside (southeast-facing) corner. It has a shingle-covered kneewall and green-painted Tuscan supports. Approaching it on its east elevation, north of center, are wood steps. The porch shelters the principal doorway. Another doorway opens in the center of the rear addition's west elevation. Gray, interlocking asphalt shingles cover the gable-on-hip roof. Green-painted wood soffit and fascia, with protruding cornice, box the eaves. The gables have eave returns, framing diamond-shaped, louvered attic vents. Red-brick chimneys protrude near the center of the roof and near the southwest corner.**

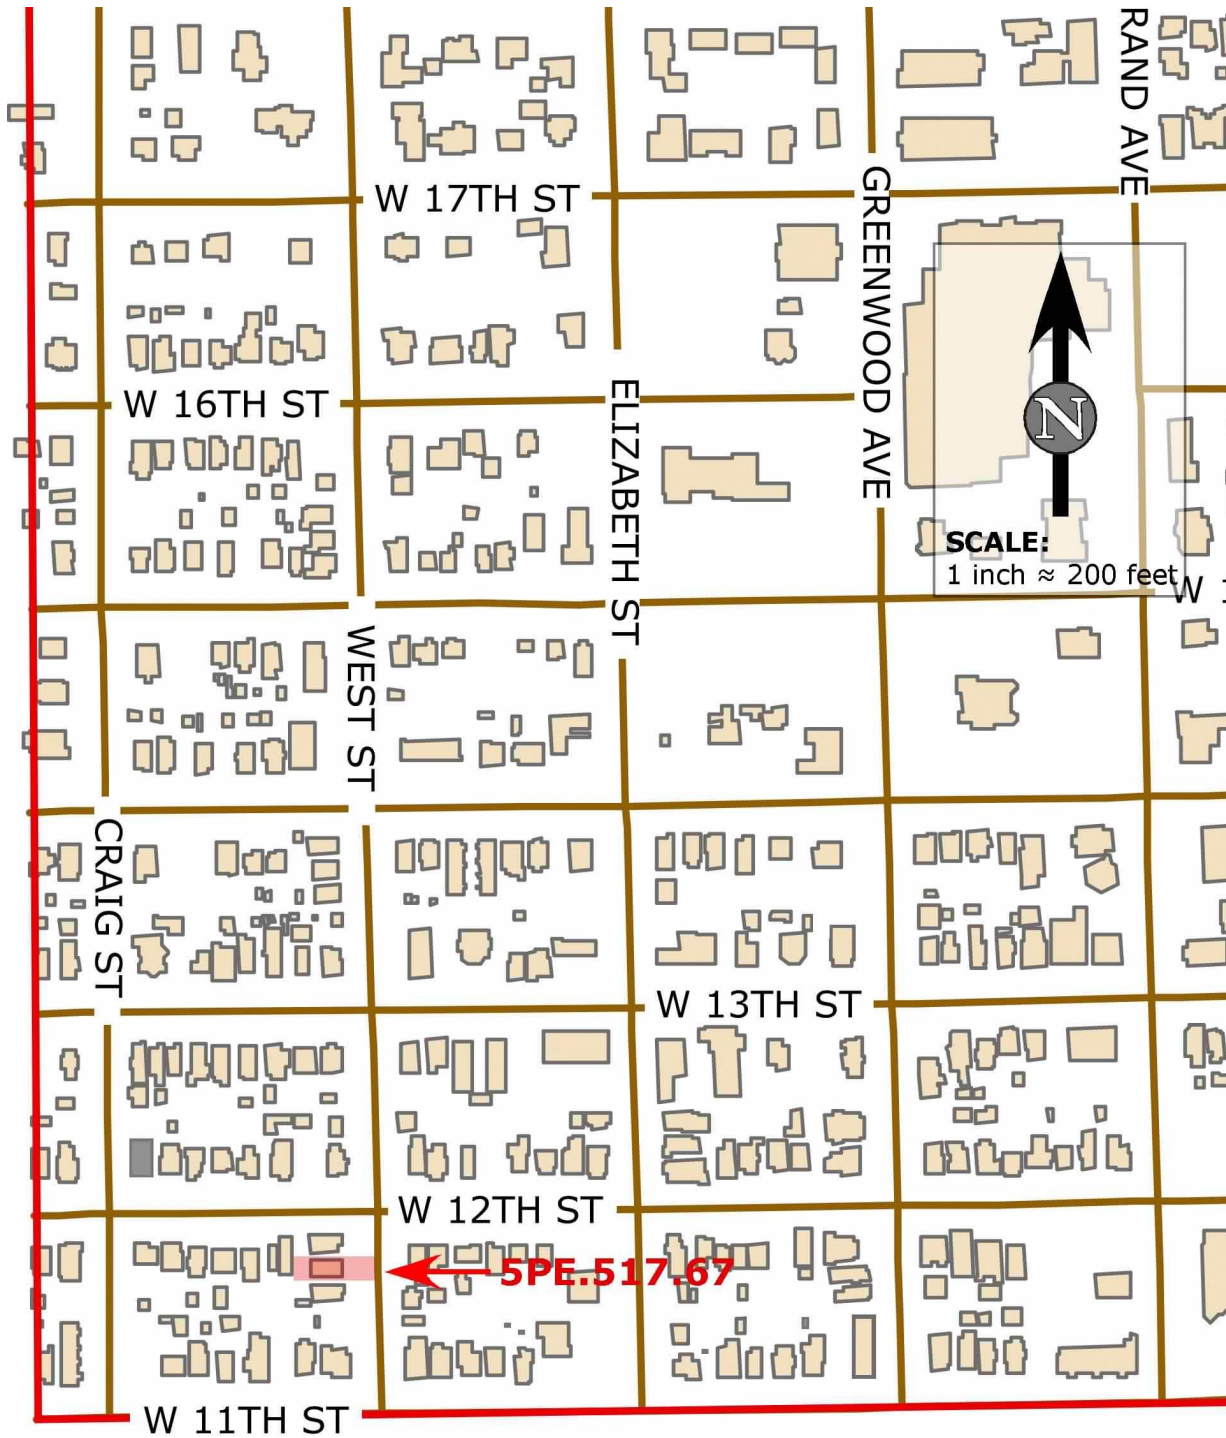
SITE SKETCH MAP

This property is located on terrain sloping downward from northeast to southwest, with an elevation of around 4,700 feet above mean sea level. The neighborhood features modest 1- and 2-story houses. Setbacks from West Street are generally the same on this block. This property is situated on the west side of West Street, between 1115 West Street to the south and 1119 West Street to the north. Separating the street from the buff-colored sandstone sidewalk is a gravel-covered strip. A planted-grass yard, with mature landscaping, covers the lot. Running along the south side of the house is a concrete driveway. A chain-link fence encircles the front yard and wood fence surrounds the back yard.

Describe: **A standard kit-built shed is located northwest of the house. Oriented to the south, the structure lacks a formal foundation. The walls consist of green-painted sheet metal. Paired, sliding doors of the same description dominate the front (south) elevation. The side-gabled roof also consists of sheet metal.**
