COLORADO CULTURAL RESOURCE SURVEY

Architectural Inventory Form

- 1. Resource number: **5PE.5856**
- 2. Temporary resource number:
- 3. County: **Pueblo**
- 4. City: **Pueblo**
- 5. Historic building name: **1501 West Street**
- 6. Current building name: **Daniel, David T., House**
- 7. Building address: **1501 West Street**
- 8. Owner name: **David T. Daniel House**
- Owner organization:
- Owner address: **305 "A" St**
- Penrose, Colorado 81240**

48. Report title: **Pueblo North Side Neighborhood Survey**

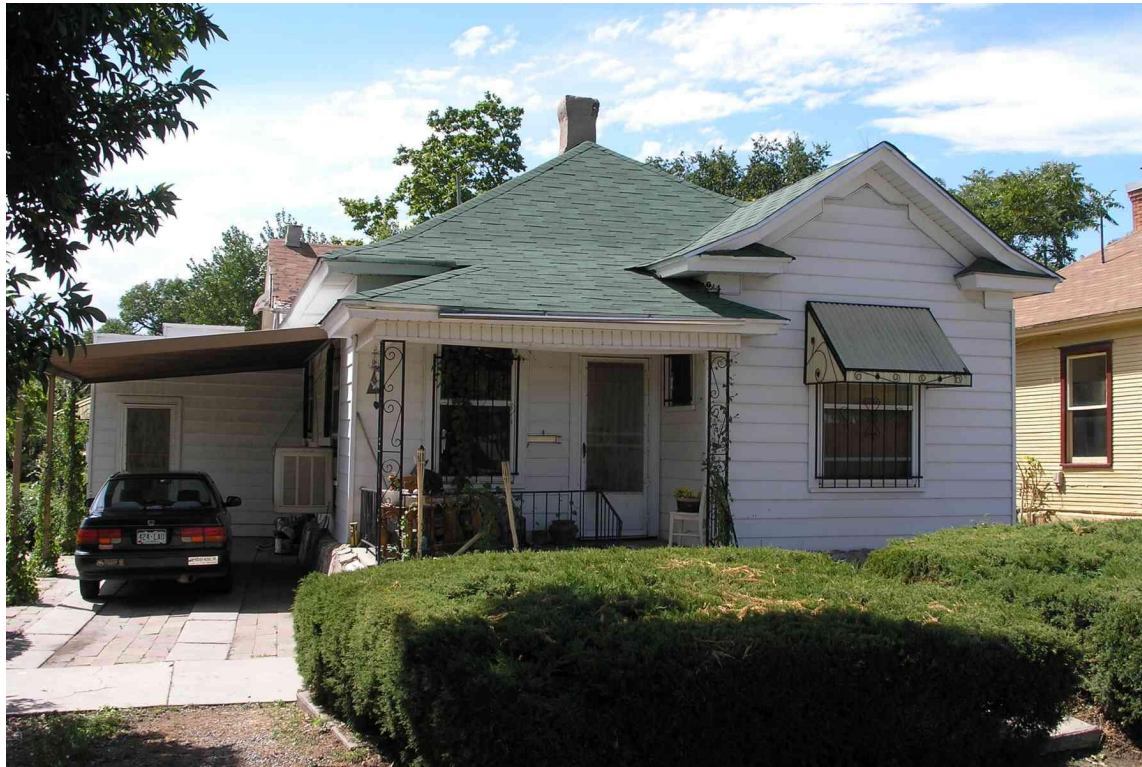
**Roof Treatment/Flared Eave**
21. General architectural description:  
**Oriented to the east, this house rests on a foundation concealed behind a random-coursed, sandstone veneer. White aluminum siding clads the exterior walls. Windows are generally 1-over-1-light, double-hung sash, with white vinyl frames and storm windows. Fiberglass awnings shelter those windows opening in the front-gabled bay. The south elevation of the attached garage hosts a 6-over-6-light, double-hung sash window, sheltered beneath a fiberglass awning. Opening in the west elevation of the garage are 1-beside-1-light, sliding sash windows, with aluminum frames. In the south face of the inside (southeast-facing) corner is a single-light casement. A hipped-roof porch spans the rest of the asymmetrical front (east) façade south of the protruding, front-gabled wing. It has a concrete floor and black, wrought-iron railings as supports. This porch shelters the principal doorway, which hosts a white-painted, paneled wood door, opening behind a white, aluminum-frame storm door. A shed-roof carport spans the south elevation east of the former garage, attached to the southwest corner of the house. The carport has steel supports and roof trusses. The east elevation of the garage once hosted a garage door, but it is now enclosed; it currently hosts a single-light, paneled wood door, painted white and opening behind an aluminum-frame storm door. Green-interlocking shingles cover the hipped main roof, and aluminum fascia and soffit box the flared eaves. The gable hosts eave returns. A brick chimney, encased in concrete, protrudes from the apex of the roof.**

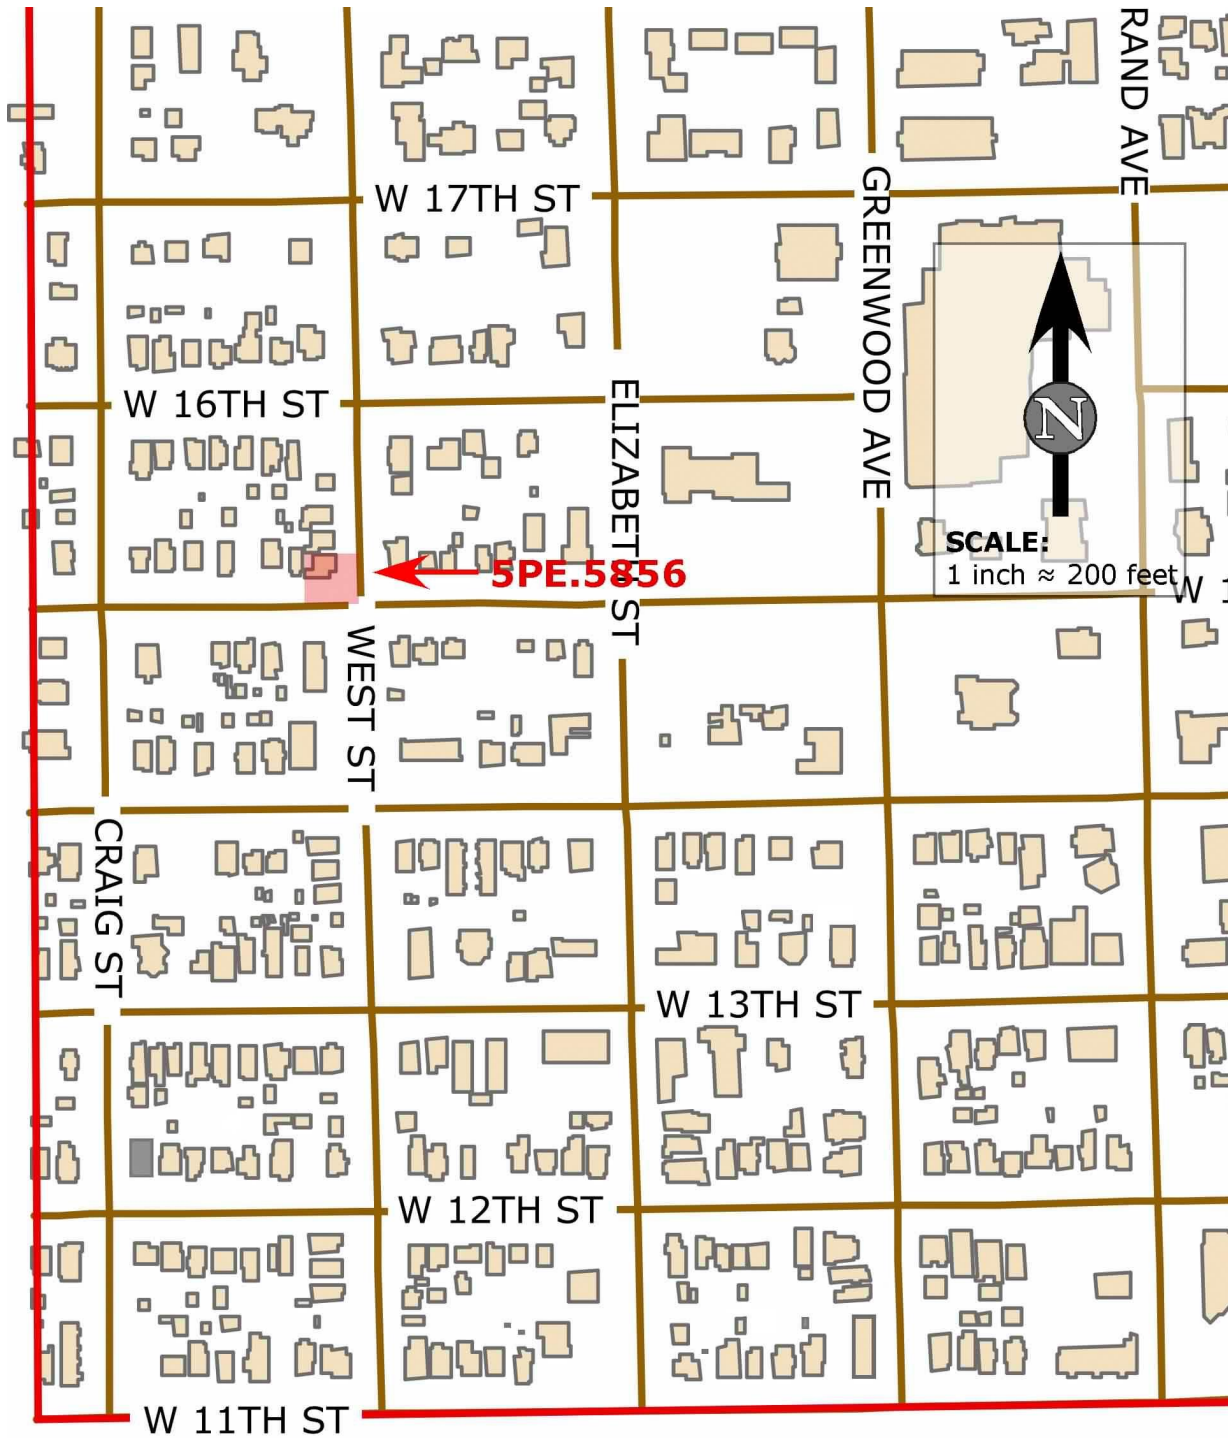
SITE SKETCH MAP

**This property is located on terrain sloping downward from northeast to southwest, with an elevation of around 4,700 feet above mean sea level. The neighborhood features modest 1- and 2-story houses and apartment buildings. Setbacks from West Street are generally the same on this block. This property is situated on the northwest corner of West and West 15th streets. Separating the street from the sidewalk is a juniper-covered strip. A planted-grass yard, with mature landscaping, covers the lot. A concrete, 2-track driveway connects West Street to the car port.**
