COLORADO CULTURAL RESOURCE SURVEY

Architectural Inventory Form

- 1. Resource number: **5PE.5857** Parcel number(s):
- 2. Temporary resource number: **525144013**
- 3. County: **Pueblo**
- 4. City: **Pueblo**
- 5. Historic building name: **Snyder, Roy C., House**
- 6. Current building name: **Molina, Pablo A., House**
- 7. Building address: **1502 West Street**
- 8. Owner name: **Pable A. Molina**
- Owner organization:
- Owner address: **1502 West St**  
**Pueblo, Colorado 81003**

47. Photograph numbers): **CD-ROM Photo Disc: North Side Photos**  
**File Name(s): westst1502**
- Negatives filed at: **Special Collections**  
**Robert Hoag Rawlings Public Library**  
**100 East Abriendo Avenue**  
**Pueblo, CO 81004-4290**
48. Report title: **Pueblo North Side Neighborhood Survey**
49. Date(s): **08/23/05**
50. Recorder(s): **Adam Thomas**
51. Organization: **Historitecture, L.L.C.**
52. Address: **PO Box 419**  
**Estes Park, CO 80517-0419**
53. Phone number(s): **(970) 586-1165**

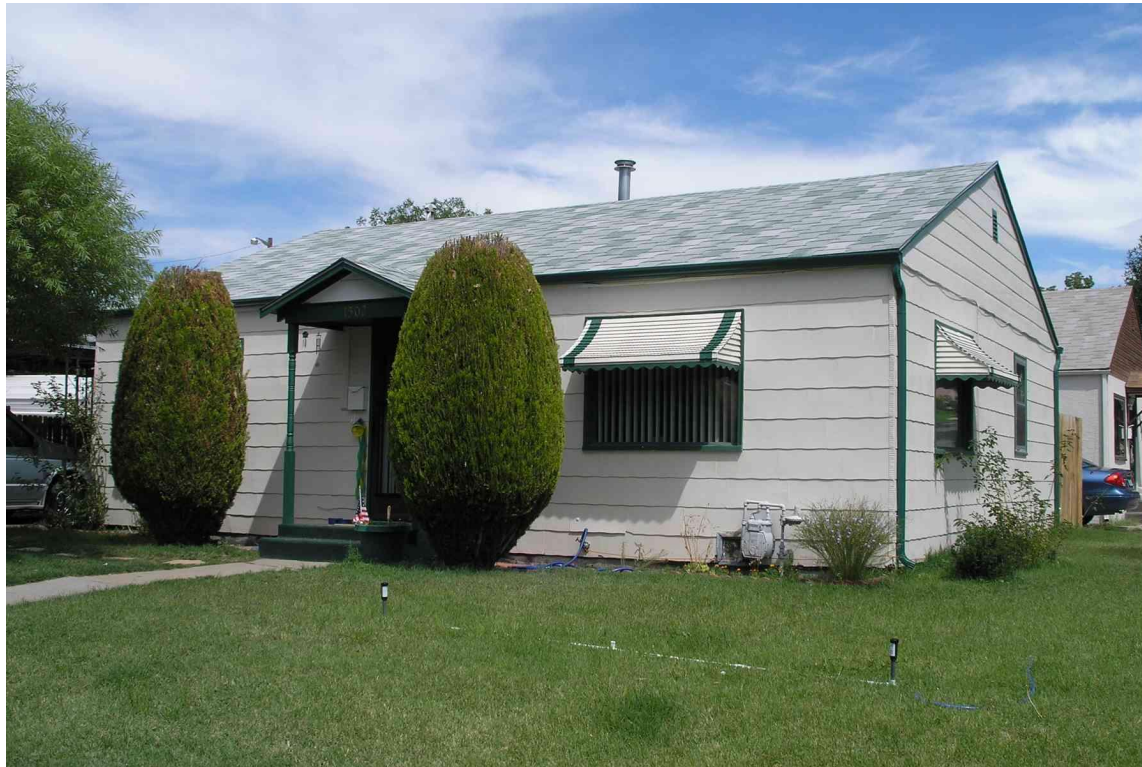
**Oriented to the west, this house rests on a concrete foundation. Cream-painted asbestos shingle siding clads the exterior walls. Broad, horizontal wooden composition siding, painted the same color, covers the gables. Windows are 1-over-1-light, double-hung sash, with white-painted wood frames, aluminum-frame storm windows, and thin, green-painted wood surrounds. Single-light picture windows pierce either face of the southwest corner. Aluminum awnings shelter these windows. The west elevation of a former garage, attached to the eastern half of the north elevation, has been enclosed and now hosts a 2 (horizontal)-over-2 (horizontal) window. The principal doorway opens in the center of the symmetrical front (west) façade. It hosts a 2-panel, 6-light wood door, painted white, opening behind a brown, aluminum-frame storm door. A 2-step concrete stoop approaches the doorway. Sheltering it is a front gabled hood, resting on green-painted, lathe-turned wood supports. Another doorway opens near the center of the house's rear (east) elevation. Opening in small, side-gabled addition to the eastern half of the former garage is a white-painted wood slab door. Gray-green asphalt shingles cover the side-gabled roof, and the building lacks overhanging eaves. A carport, consisting of a wrought-iron structure and fiberglass roof, is located in front (west) of the attached former garage.**

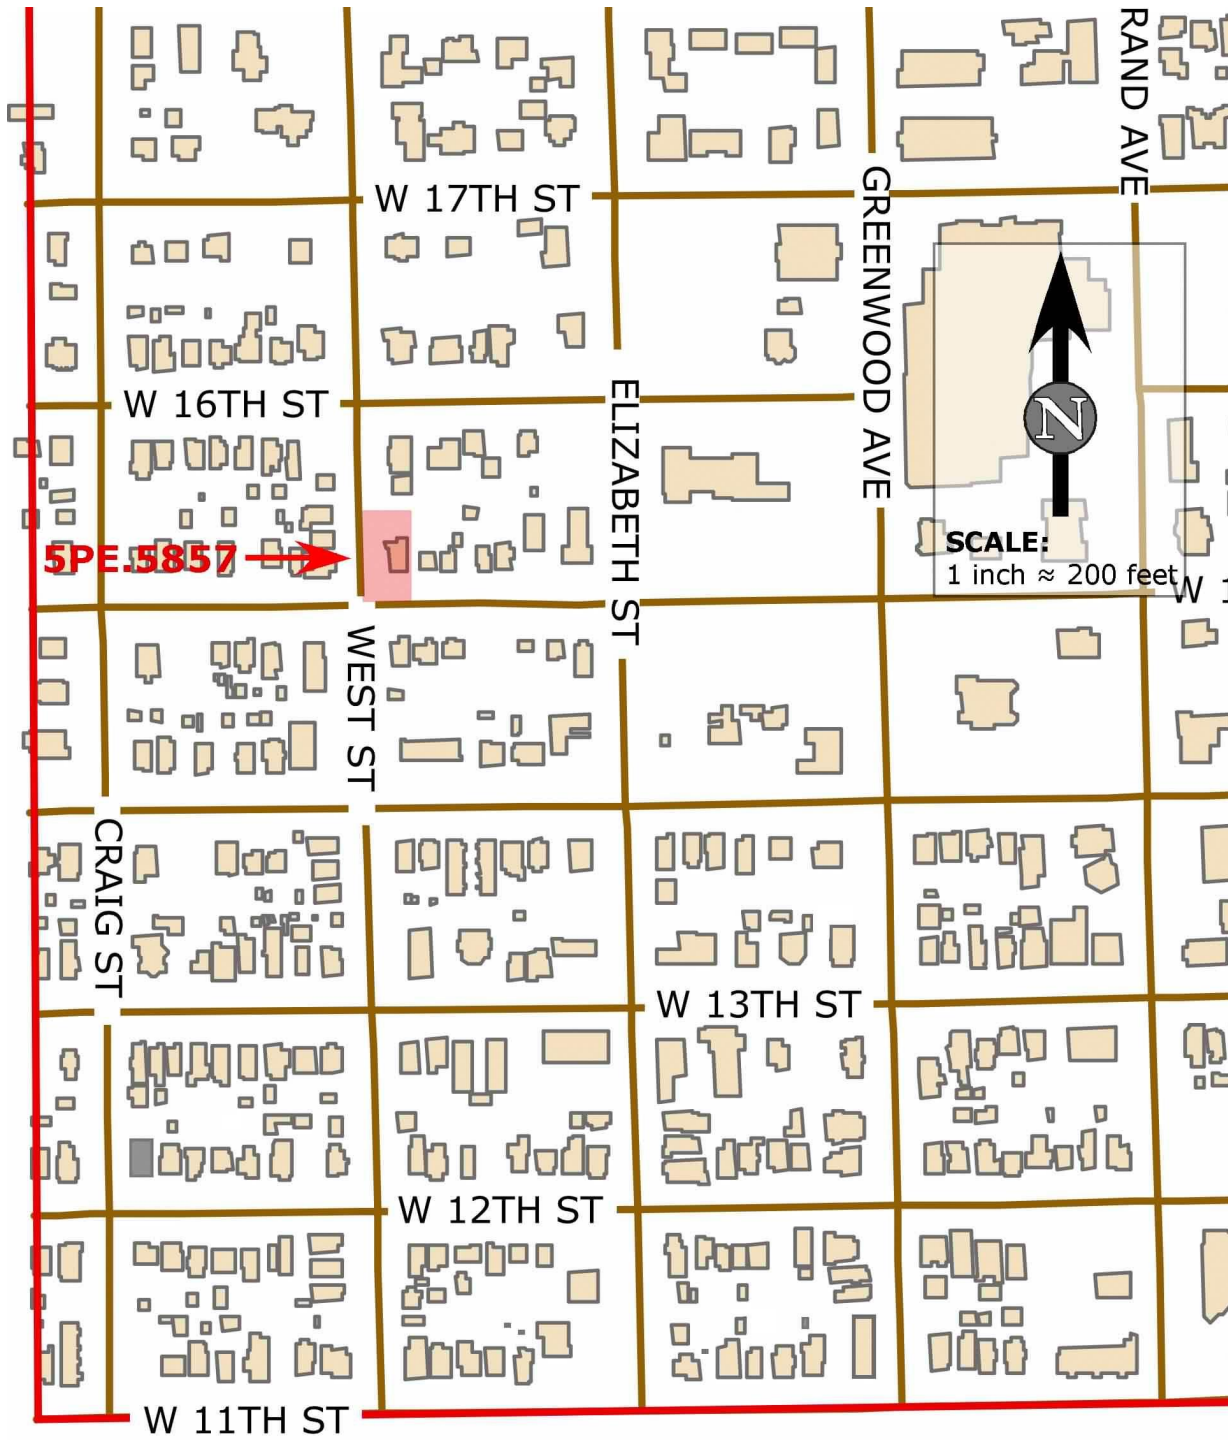
#### SITE SKETCH MAP

**This property is located on terrain sloping downward from northeast to southwest, with an elevation of around 4,700 feet above mean sea level. The neighborhood features modest 1- and 2-story houses and apartment buildings. Setbacks from West Street are generally the same on this block. This property is situated on the northeast corner of West and West 15th streets. Separating the street from the sidewalk is a grass strip. A planted-grass yard, with mature landscaping, covers the lot. Connecting the carport to West Street is a gravel driveway. A wood privacy fence encircles the back yard.**
