COLORADO CULTURAL RESOURCE SURVEY

Architectural Inventory Form

- 1. Resource number: **5PE.5859** Parcel number(s):
- 2. Temporary resource number: **525145006**
- 3. County: **Pueblo**
- 4. City: **Pueblo**
- 5. Historic building name: **Titus, Horace L., House**
- 6. Current building name: **MacKnight, Steven Lee, House**
- 7. Building address: **1505 West Street**
- 8. Owner name: **Steven Lee MacKnight**
- Owner organization:
- Owner address: **1505 West St**
Pueblo, Colorado 81003

48. Report title: Pueblo North Side Neighborhood Survey

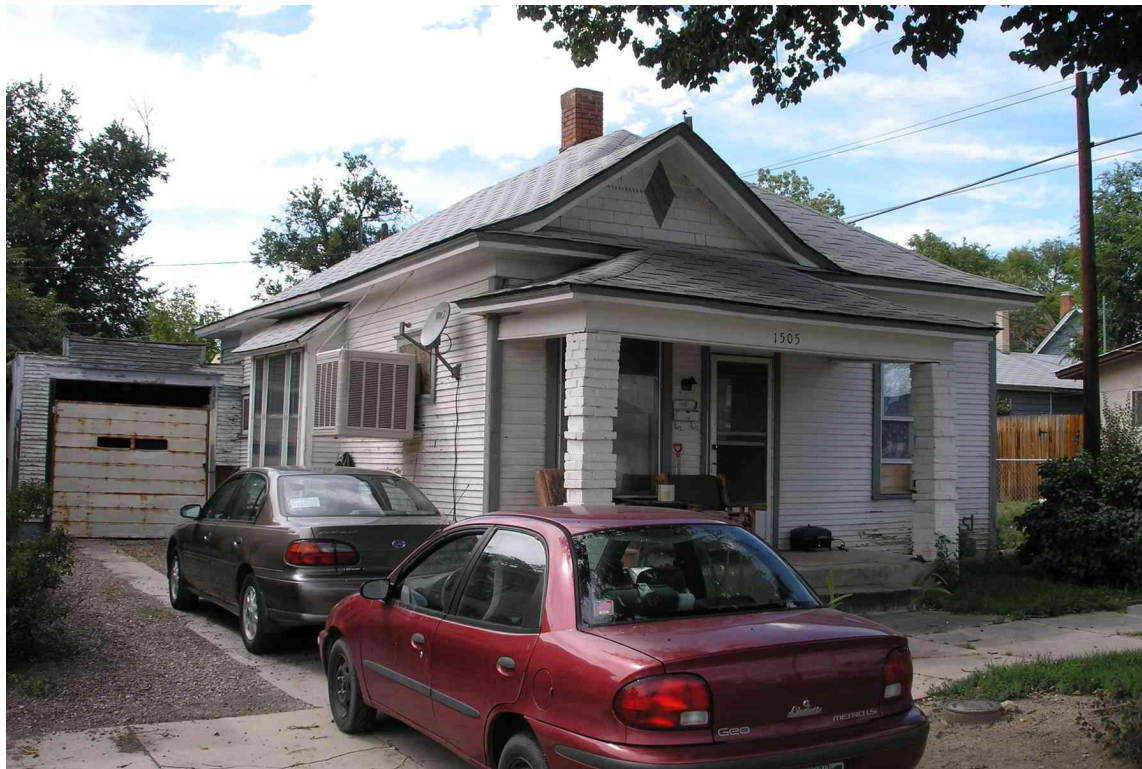
21. General architectural description:
Oriented to the east, this house rests on a sandstone foundation, encased in concrete. Narrow, white-painted, horizontal wood siding, with gray-painted cornerboards, clads the exterior walls. Square-cut wood shingles, with a single course of saw-toothed shingles, covers the front (east-facing) gable. Windows are generally 1-over-1-light, double-hung sash, with white-painted wood frames, aluminum-frame storm windows, and gray painted wood surrounds with projecting cornices. A set of 3 windows of this description dominate a rectangular, cantilever bay protruding from the south elevation. The bay has its own shed roof. Some windows have been replaced with aluminum-frame sashes. Opening in either end of the north elevation are single-light awning or hopper windows. West of the protruding bay on the south elevation is a 1-beside-1-light, sliding sash window, with a vinyl frame. A hipped-roof porch protrudes from the southern two-thirds of the asymmetrical front (east) elevation. It has a concrete floor, white-painted brick piers, and lacks a railing. The porch shelters the principal doorway, which hosts a 6-panel, steel door, painted white, opening behind an aluminum-frame storm door. Another doorway opens in the rear (west) elevation, beneath a shed-roofed porch. A single-car garage is attached to the southwest corner of the house. Dominating its east elevation is a 2-light, steel, overhead-retractable garage door, painted white. Gray, interlocking asphalt

shingles cover the gable-on-hip roof, and white-painted beadboard soffit and gray-painted fascia, with projecting cornice, box the flared eaves. A red-brick chimney protrudes from the apex of the roof.

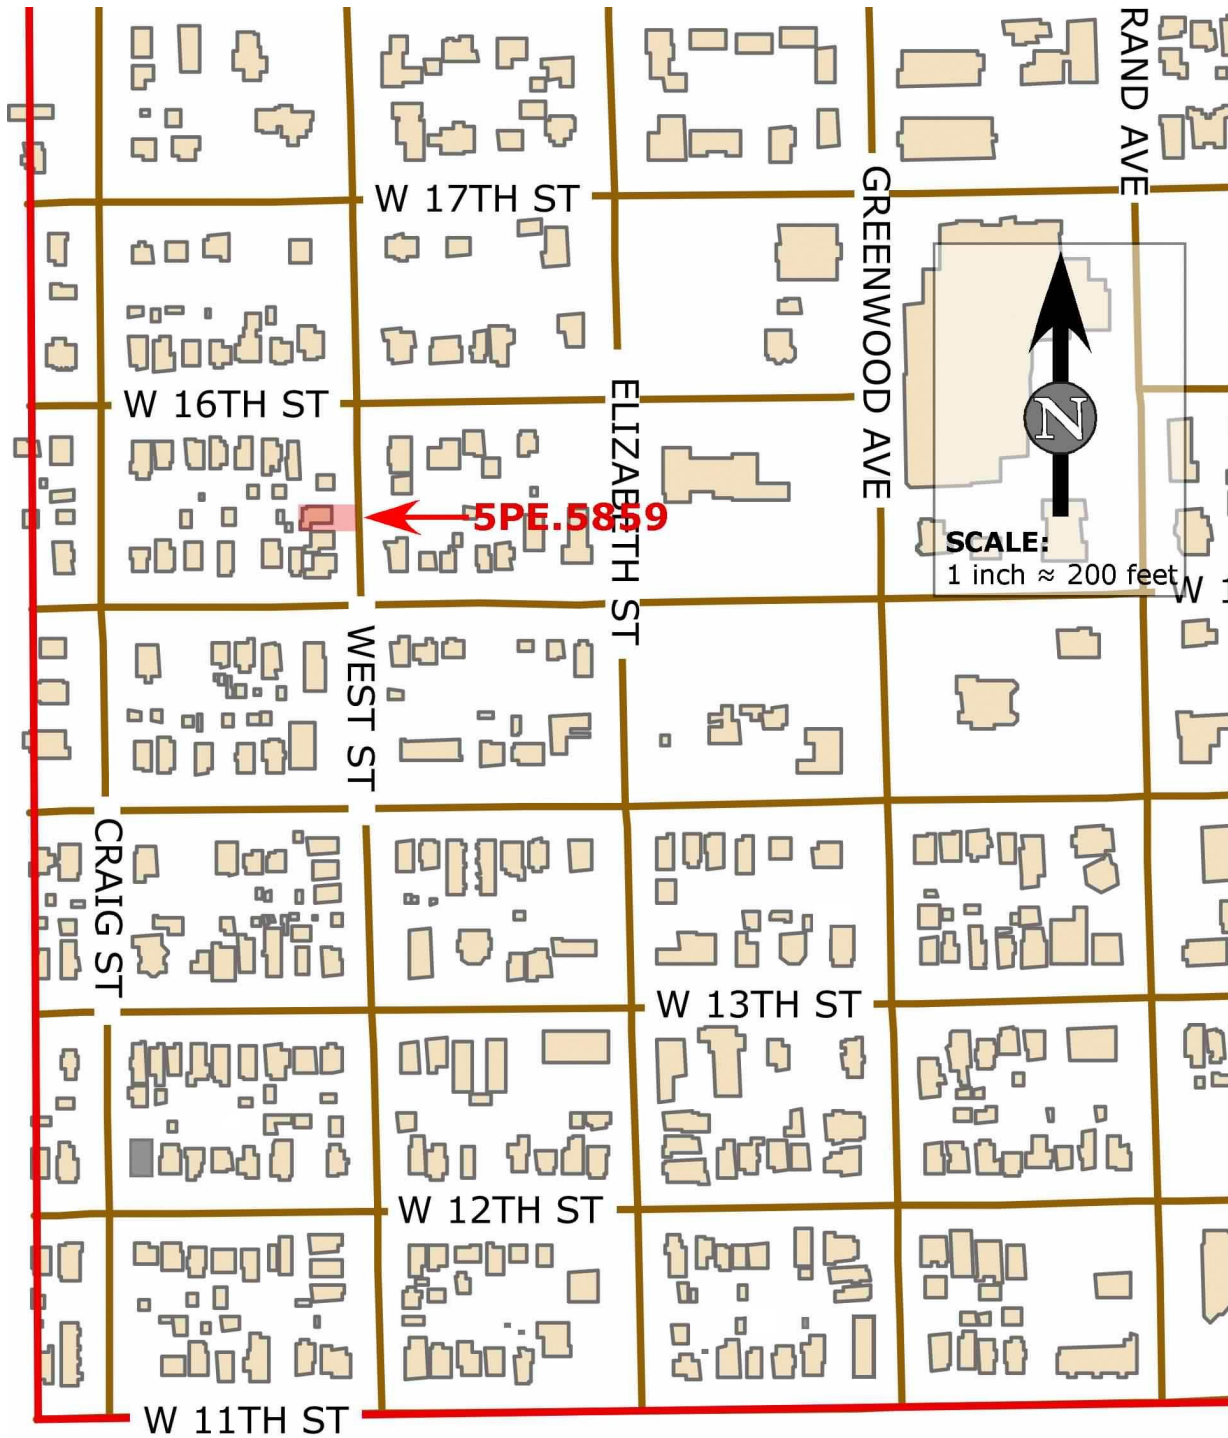
SITE SKETCH MAP

This property is located on terrain sloping downward from northeast to southwest, with an elevation of around 4,700 feet above mean sea level. The neighborhood features modest 1- and 2-story houses and apartment buildings. Setbacks from West Street are generally the same on this block. This property is situated on the west side of West Street, between 1503 West Street to the south and an east-west-oriented alley to the north. Separating the street from the sidewalk is a grass strip. A planted-grass yard, with mature landscaping, covers the lot. Connecting the attached garage to West Street is a concrete, 2-track driveway.
