COLORADO CULTURAL RESOURCE SURVEY

Architectural Inventory Form

- 1. Resource number: **5PE.5861** Parcel number(s):
- 2. Temporary resource number: **525144004**
- 3. County: **Pueblo**
- 4. City: **Pueblo**
- 5. Historic building name: **1520 West Street**
- 6. Current building name: **Hiser, Randy W. and Melanie A., House**
- 7. Building address: **1520 West Street**
- 8. Owner name: **Randy W. and Melanie A. Hiser**
- Owner organization:
- Owner address: **1520 West St**
Pueblo, Colorado 81003

47. Photograph numbers): **CD-ROM Photo Disc: North Side Photos**
File Name(s): westst1520
- Negatives filed at: **Special Collections**
Robert Hoag Rawlings Public Library
100 East Abriendo Avenue
Pueblo, CO 81004-4290
48. Report title: **Pueblo North Side Neighborhood Survey**
49. Date(s): **08/23/05**
50. Recorder(s): **Adam Thomas**
51. Organization: **Historitecture, L.L.C.**
52. Address: **PO Box 419**
Estes Park, CO 80517-0419
53. Phone number(s): **(970) 586-1165**

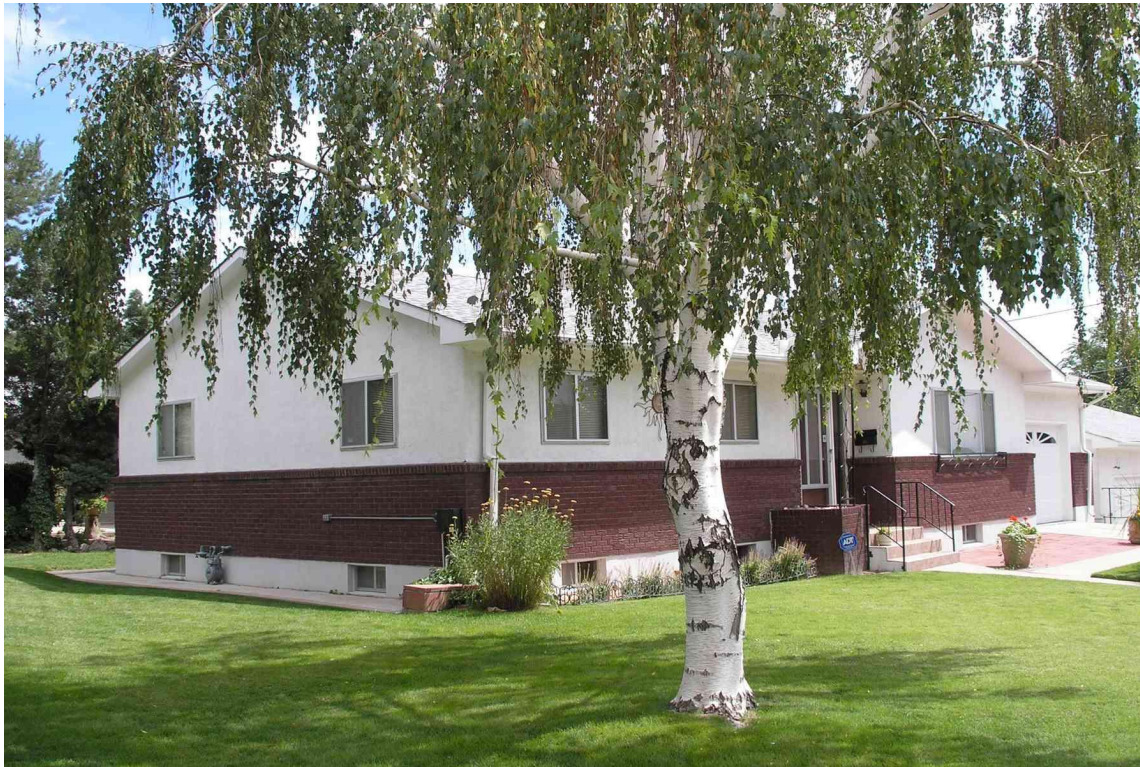
19. Primary external roof material: **Asphalt Roof/Composition Roof**
Other roof materials:
20. Special features: **Chimney**
Garage/Attached Garage
Porch
21. General architectural description:
Oriented to the west, this house rests on a white-painted concrete foundation, with 1-beside-1-light, sliding sash basement windows. White stucco clads most of the exterior walls, except for the lower 4 feet of the north, west, and south elevations, which have a red-brick veneer. Windows are 1-beside-1-light, sliding sash, with aluminum frames. Larger windows are tripartite, with the center light fixed. An integral porch is located in the northern third of a front-gabled wing protruding from the asymmetrical front (west) façade. It has a concrete floor and a wrought-iron railing. This porch shelters the principal doorway, which hosts a single-light wood slab door, opening behind an aluminum-frame storm door. A sidelight is south of the door. A single-car garage is attached to the south end of the building. Its west elevation hosts a white, 6-panel, overhead-retractable garage door, with a fanlight. Gray asphalt shingles cover the cross-gabled roof, and white-painted wood fascia and soffit box the broadly overhanging eaves.

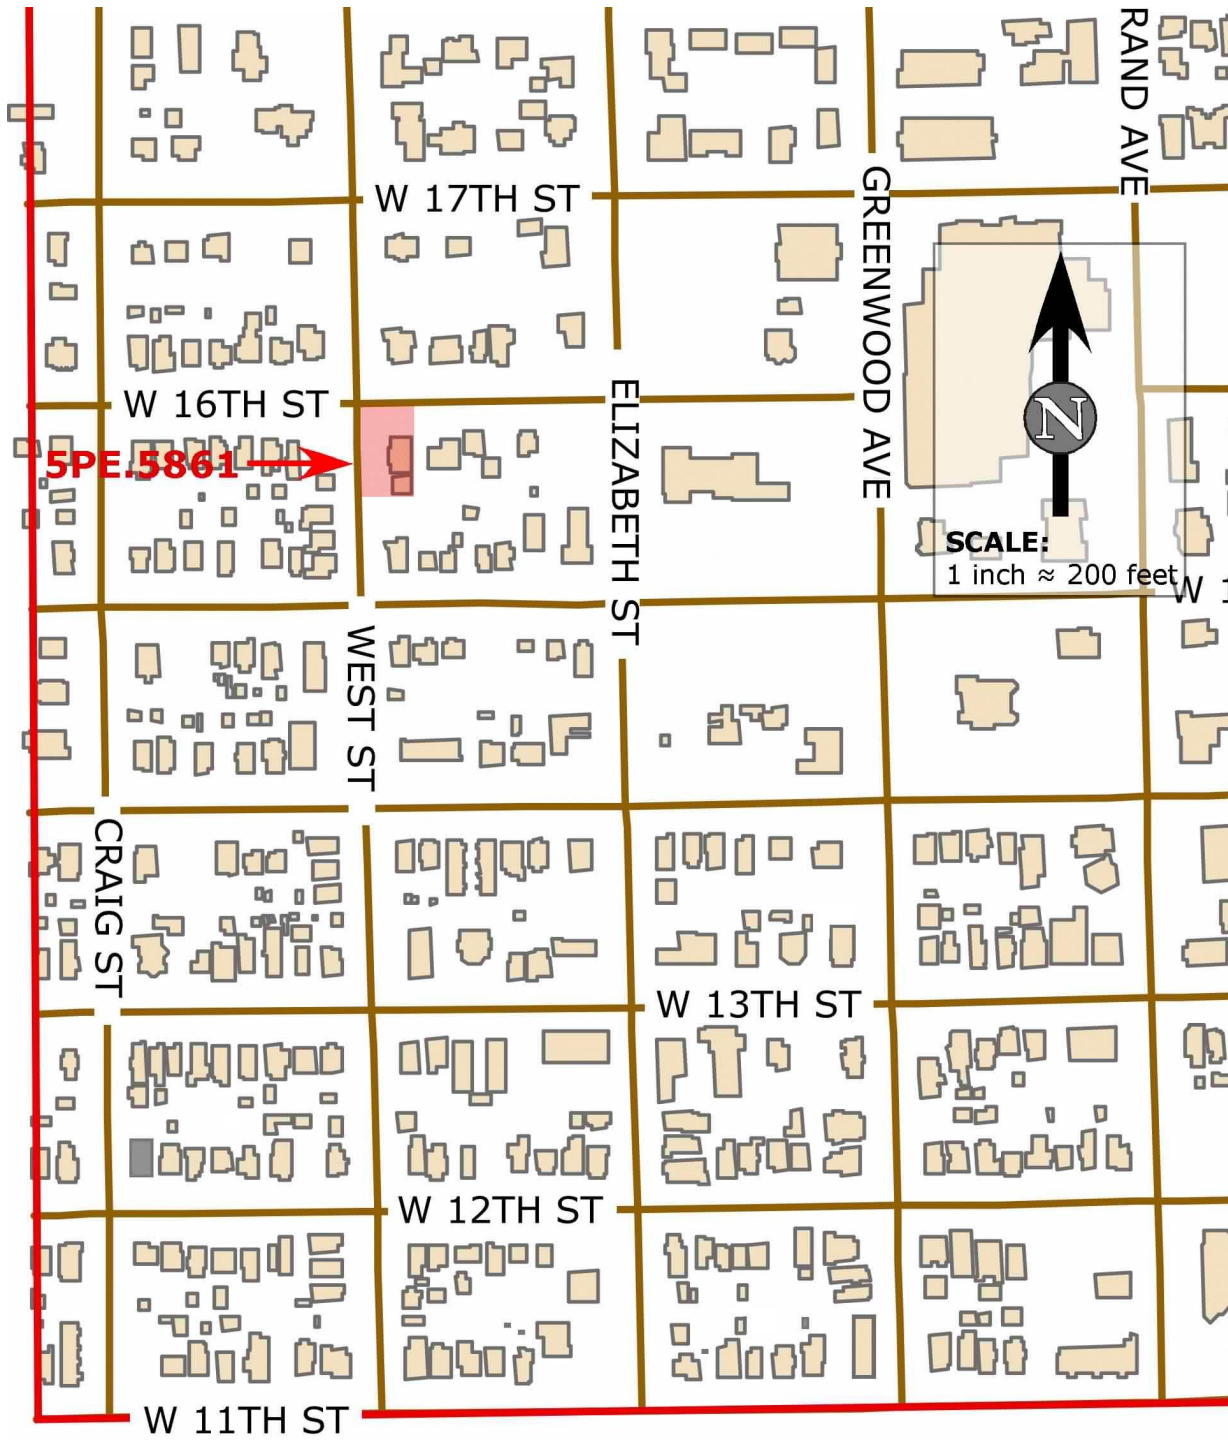
SITE SKETCH MAP

This property is located on terrain sloping downward from northeast to southwest, with an elevation of around 4,700 feet above mean sea level. The neighborhood features modest 1- and 2-story houses and apartment buildings. Setbacks from West Street are generally the same on this block. This property is situated on the southeast corner of West and West 15th streets. A lush, planted-grass yard, with mature landscaping, covers the lot.
