COLORADO CULTURAL RESOURCE SURVEY

Architectural Inventory Form

- 1. Resource number: **5PE.517.28**
- 2. Temporary resource number: **048**
- 3. County: **Pueblo**
- 4. City: **Pueblo**
- 5. Historic building name: **Leach, A.L., House**
- 6. Current building name: **Baca, Rachel G., House**
- 7. Building address: **623 W 12th Street**
- 8. Owner name: **Rachel G. Baca**
- Owner organization:
- Owner address: **623 W 12th St**
Pueblo, CO 81003

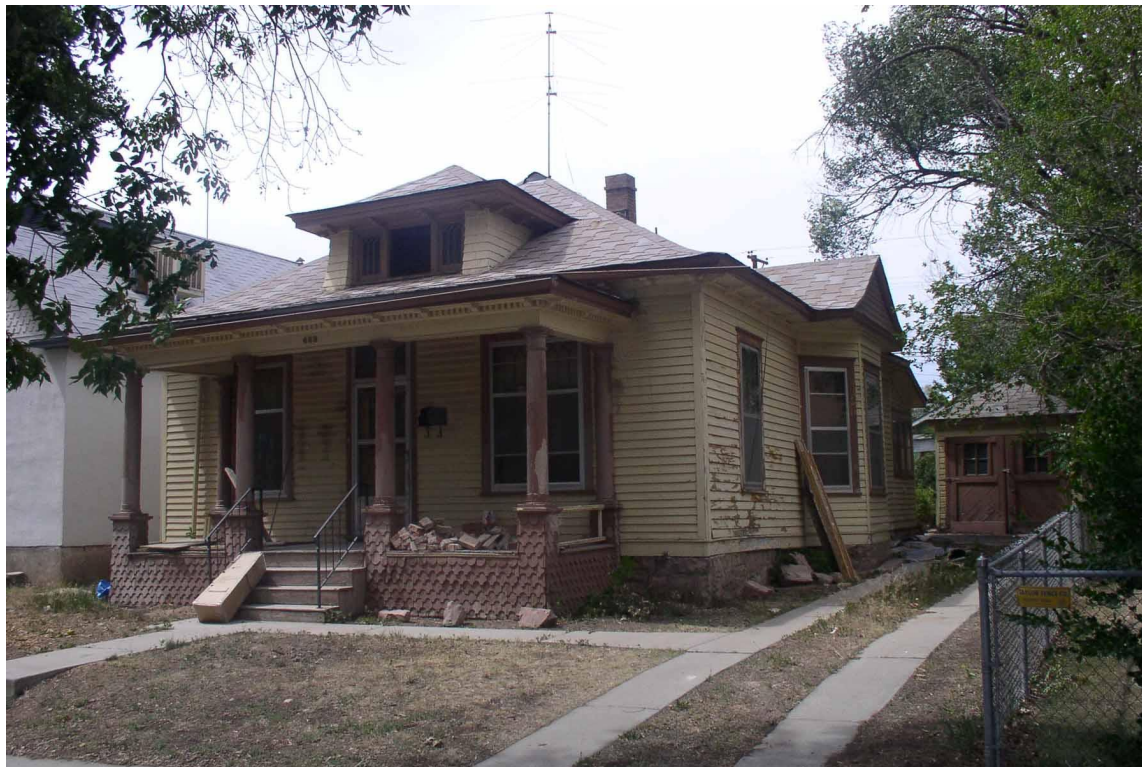
21. General architectural description:
Oriented to the south, this house rests on a pink, random-laid sandstone foundation. Yellow-painted, horizontal wood siding, with 1-by-4-inch cornerboards, clads the exterior walls. Covering a hipped-roof dormer, protruding from the roof's south-facing slope, are yellow-painted, square-cut wood shingles. Windows are 1-over-1-light, double-hung sash, with brown-painted wood frames, aluminum-frame storm windows, and brown-painted wood surrounds. The surrounds have projecting cornices. The top sashes of windows in the front (south) façade have diamond-shaped glazing. The east window is much wider than the west. Above them, in the gable, are three hopper or awning windows, also with diamond-shaped glazing. A canted bay window, beneath a front-gable roof, protrudes from the center of the east elevation. A hipped-roof porch spans most of the front (south) façade. It features a wood floor and beadboard ceiling. The porch supports rest on pedestals covered in brown-painted, decorative wood shingles. These shingles also cover the space between the porch floor and the ground. The porch supports themselves are brown-painted, wood Tuscan columns. The porch has a dentiled cornice with evenly modillions. Three wood

steps, with flanking, wrought-iron railings, approach the porch at its center. The principal doorway opens just west of center in the otherwise symmetrical façade. It hosts a 5-panel, 1-light, glass-in-wood-frame door, with projecting top and locking rails. Carved swags appear beneath the locking rail and above the top rail. Another floral motif is carved into the center panel. Above the door is a single-light transom. The door opens behind an aluminum-frame storm door. Another doorway opens within a shed-roofed addition to the eastern two-thirds of the rear (north) elevation. It hosts a 4-panel, 1-light, glass-in-wood frame door, opening behind an aluminum-frame storm door. Approaching the door is a 2-step concrete stoop. Brown-gray interlocking asphalt shingles cover the centrally hipped roof. The eaves are flared and boxed with yellow-painted, beadboard soffit and brown-painted fascia. Beneath the broadly overhanging eaves are evenly spaced modillions. A tall, tan-brick, corbelled chimney emerges near the apex of the roof.
