COLORADO CULTURAL RESOURCE SURVEY

Architectural Inventory Form

- 1. Resource number: **5BL.10458** Parcel number: **158321213006**
- 2. Temporary resource number:
- 3. County: **Boulder**
- 4. City: **Eldora**
- 5. Historic building name: **“Doctor’s Rx” Cabin; Hershhal and Tina Terrell Cabin**
- 6. Current building name: **“Doctor’s Rx” Cabin; Douglas and Scott Campbell Cabin**
- 7. Building address: **355 Bryan Avenue**
- 8. Owner name: **Douglas H. and Scott D. Campbell**
- Owner organization:
- Owner address: **4455 W Custer Pl  
Denver, CO 80219**

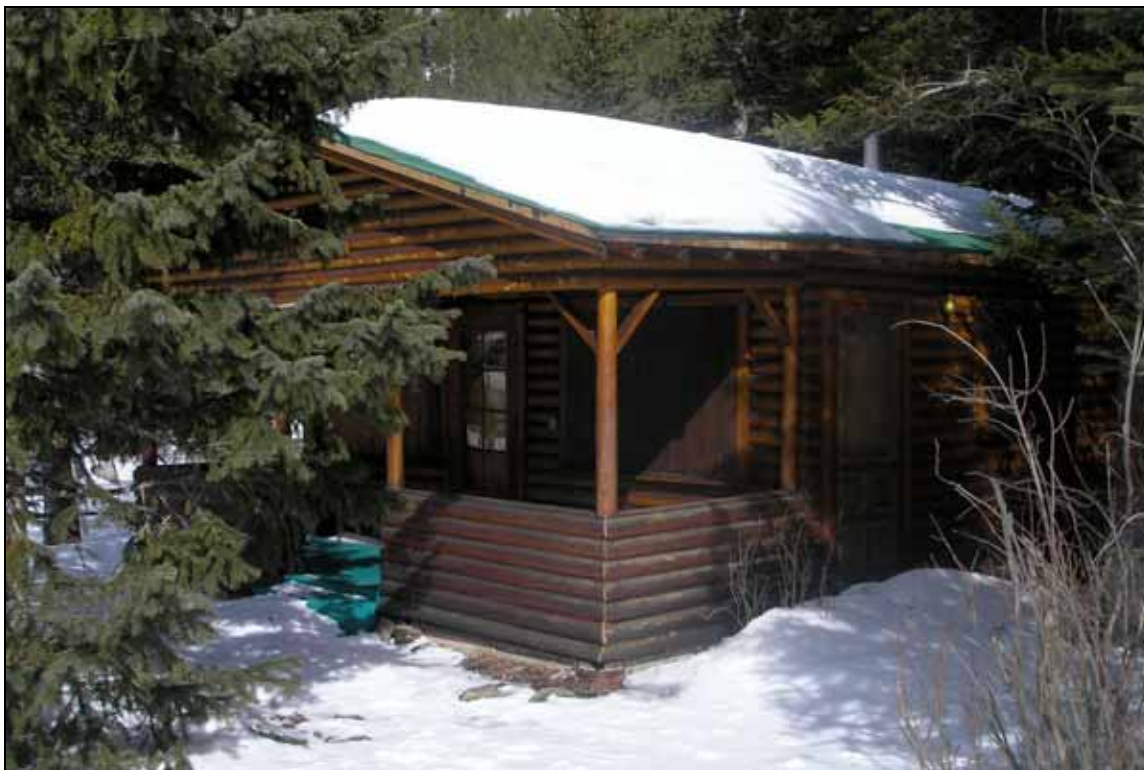
**Oriented to the west, this cabin rests on a concrete foundation. It consists of an L-shaped plan, with the inside corner facing northwest. Simulated log siding clads the exterior walls. Most of the windows were concealed behind wood shutters at the time of this survey. However, those that were visible were 6-light hopper, awning, or casement, with wood frames. An integral porch spans the entire front (west) facade of the east-west leg of the L. It features log siding-clad kneewalls and stickwork supports. Approaching the center of the porch are green-painted wood steps. They align to the principal doorway, which hosts a vertical plank door, with a single light, opening behind a wood-frame storm door. Another doorway opens in the west end of the south elevation. Green sheets of asphalt cover the cross-gable roof, and the rafter ends are exposed. A random-coursed granite hearth and chimney is situated within the inside corner of the L.**
