COLORADO CULTURAL RESOURCE SURVEY

Architectural Inventory Form

- 1. Resource number: **5BL.10449** Parcel number: **158321217001**
- 2. Temporary resource number:
- 3. County: **Boulder**
- 4. City: **Eldora**
- 5. Historic building name: **Amos and Marie Entwistle Cabin**
- 6. Current building name: **Carlson-Parrish Cabin**
- 7. Building address: **498 Eldorado Avenue**
- 8. Owner name: **Lisa H. Carlson and Frank A. Parrish**
- Owner organization:
- Owner address: **1439 Gay St  
Longmont, CO 80501**

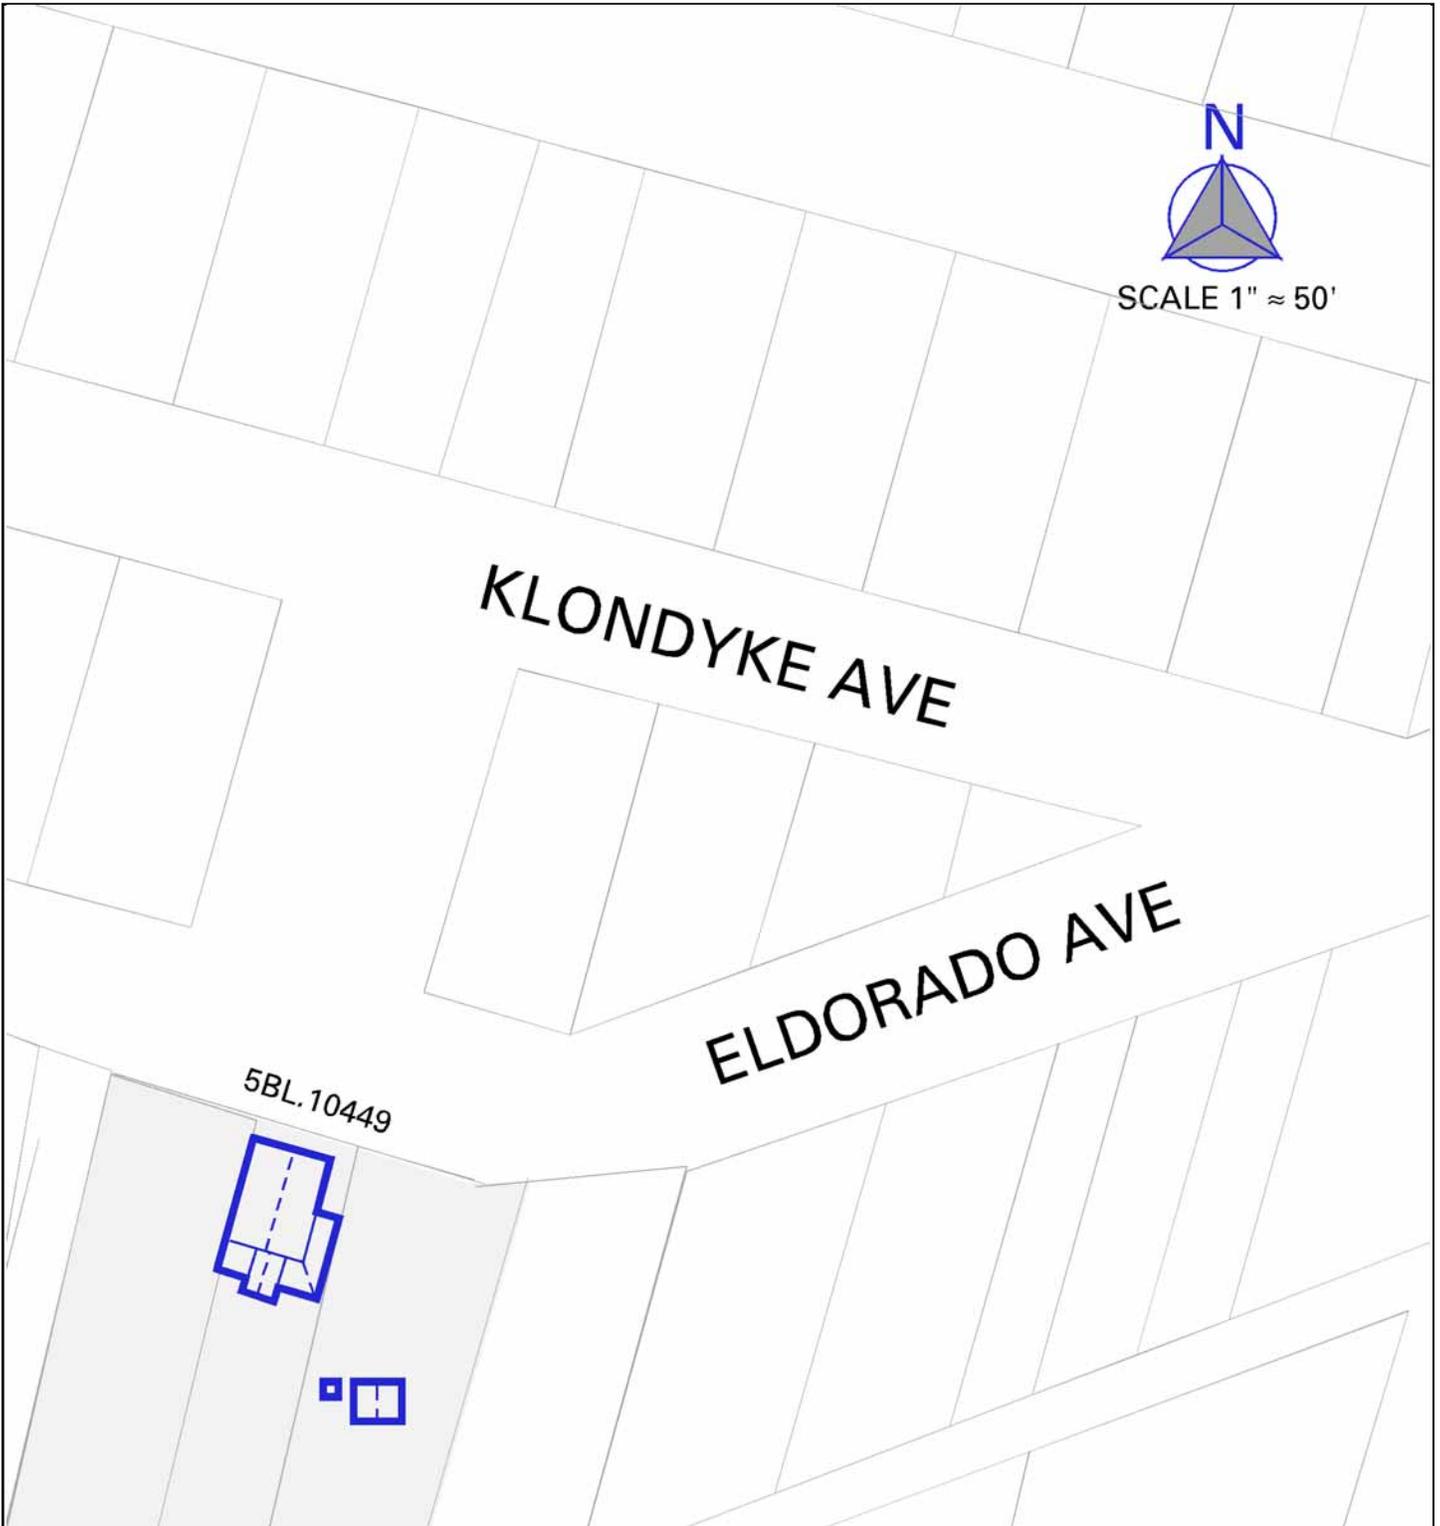
SKETCH MAP

A shed is located northeast of the cabin and immediately east of the privy. Oriented north, this shed has no formal foundation. Walls consist of unpainted vertical wood planks with no windows. There are two doorways spaced equally apart in the north elevation. The easternmost doorway is barricaded with unpainted horizontal wood planks. The westernmost doorway hosts a door of unpainted vertical wood planks. Sheets of corrugated tin cover the front-gabled roof.

A privy is located southeast of the cabin and immediately west of the shed. Oriented to the west, the building lacks a formal foundation. The walls consist of unpainted vertical wood planks, and a small vent opens in the north-facing gable. The door is located on the west elevation, offset to the south. Sheets of corrugated tin cover the side-gabled roof.
